HOUSING COMMITTEE

Non-Traditional Homes Summary Property Review

Prepared for:
Stroud District Council
Council Offices
Ebley Mill
Ebley Wharf
STROUD
Gloucestershire
GL5 4UB

Curtin's Consulting Limited were appointed by Stroud District Council (referred to in their report as SDC or the Council) to undertake a survey and prepare a report on the condition of the remaining non-traditional properties which remain with the Councils housing portfolio.

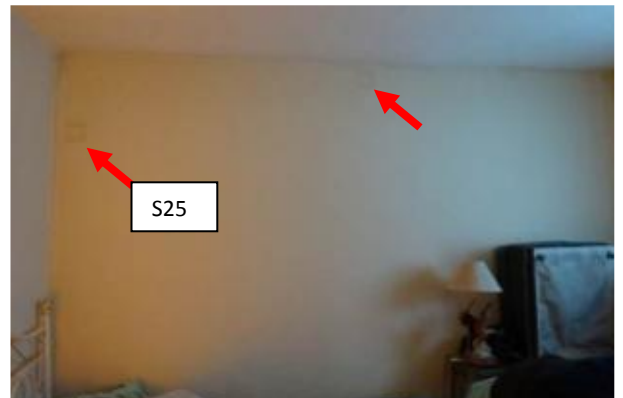
S24 – 45 Lawnside, Forest Green, bedroom gable
wall, two small square areas of staining
(arrowed). Photo S26 is to the right side.

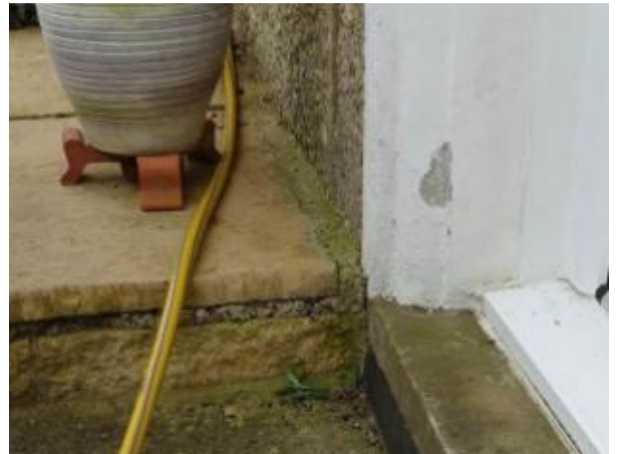
S28 – 18 Lawnside, Forest Green, paving to left of front door too high

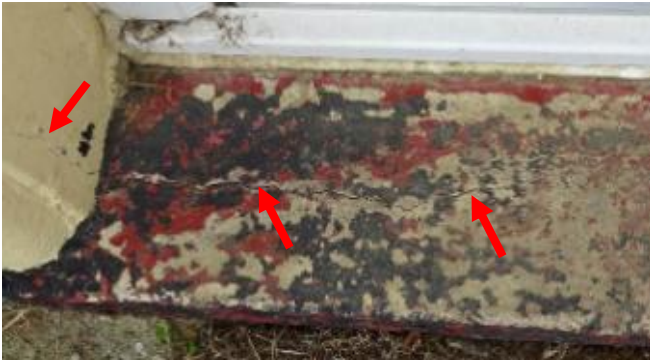
S31 – 51/52 Mankley Road, Leonard Stanley. Crack on door step extending up onto reveal

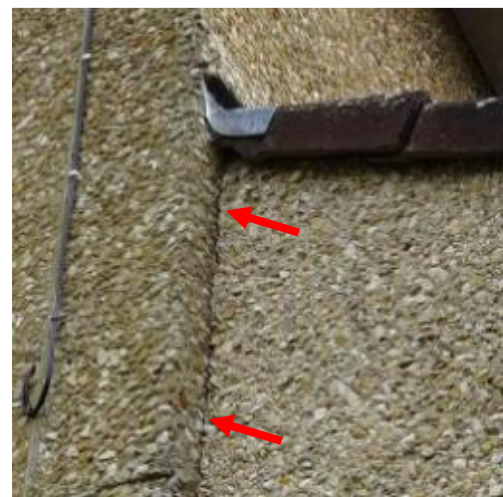
S40 – 6 Upper Park Road, Nailsworth. Cracking at junction of side extension & main house

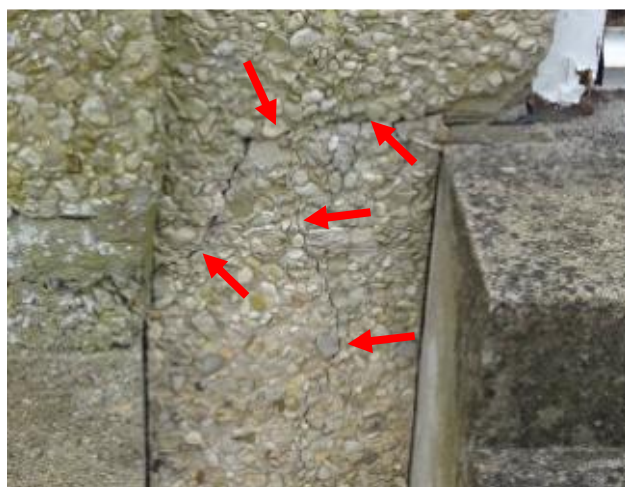
S41 – 6 Upper Park Road, Nailsworth. Cracking at dpc to side of door

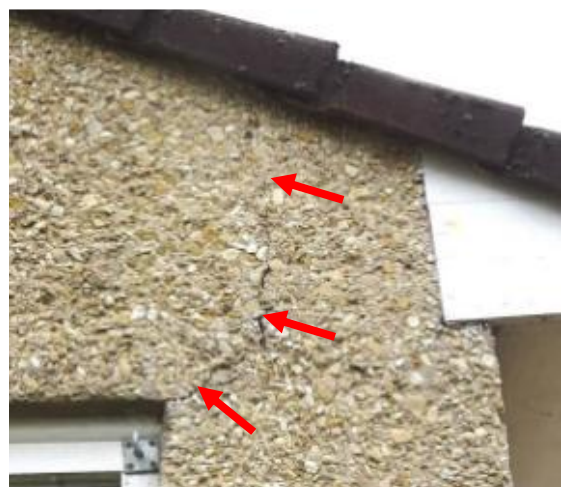
S42 – 6 Upper Park Road, Nailsworth. Cracking above door

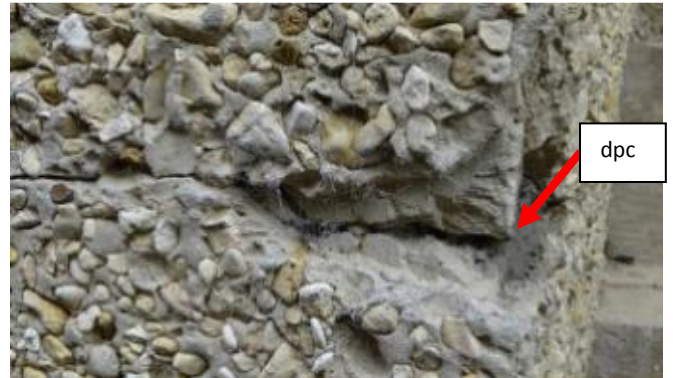
S44 – 6 Upper Park Road, Nailsworth. Side extension, cracking at dpc level detail

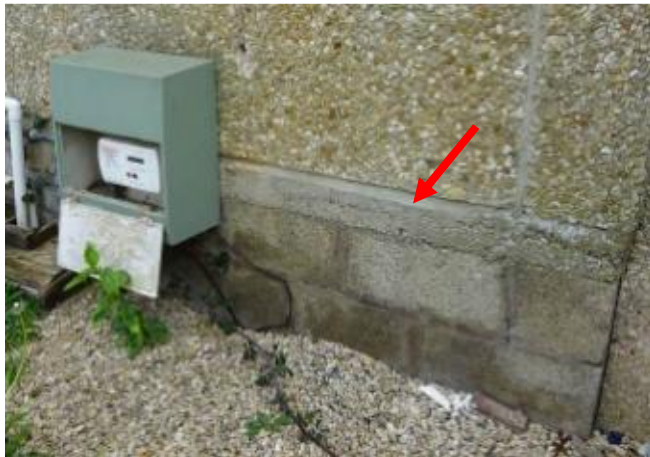
S45 – 6 Upper Park Road, Nailsworth. Rear corner main house. Cast in-situ concrete (arrowed) & blockwork suggests underpinning

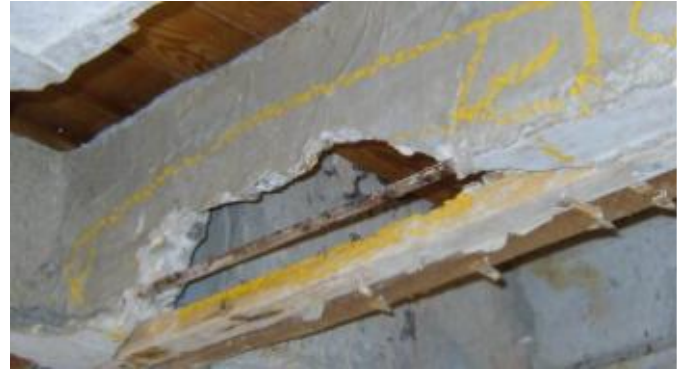
S50 – Typical PRC beam defect (not taken in SDC stock)

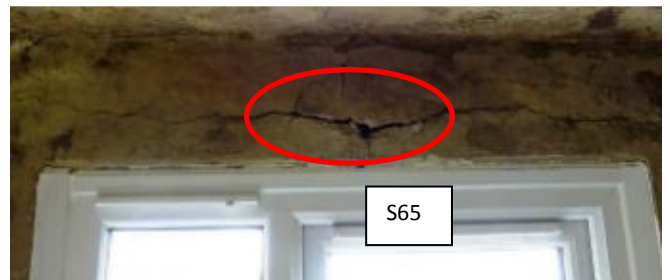
S64 – 31 Victory Road, Whiteshill. Side extension cracking above window viewed internally

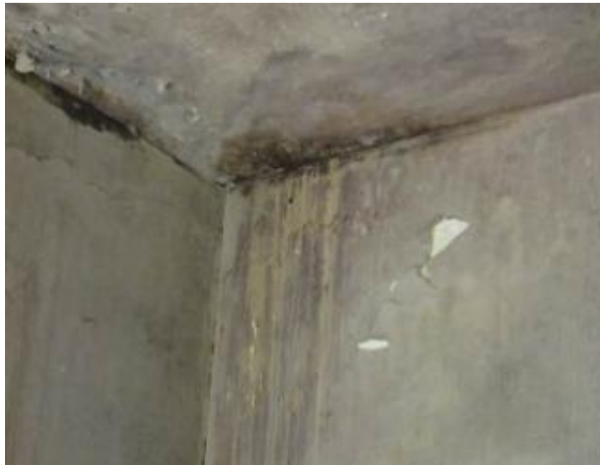
S69 – 31 Victory Road, Whiteshill. Side extension mould & damp ingress staining in front corner

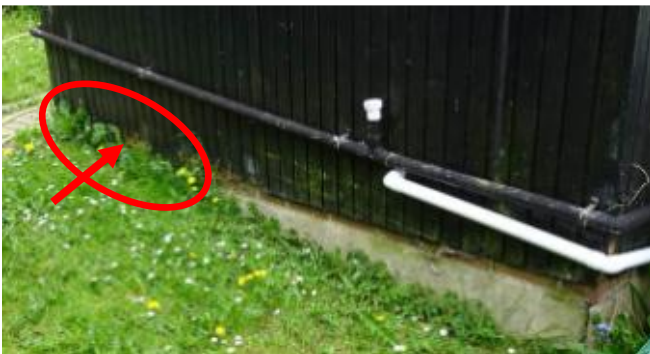
T9 – 32 Barrs Lane, North Nibley. Outbuilding side, ground level too high (circled). Rot to outer boards at dpc level (T10 circled)

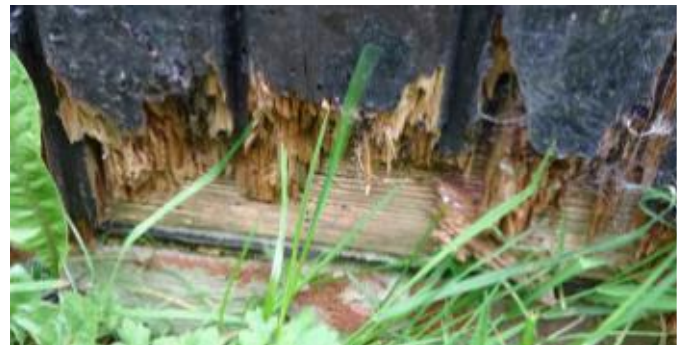
T10 – 32 Barrs Lane, North Nibley. Outbuilding side, rotten timber outer boards & keel plate

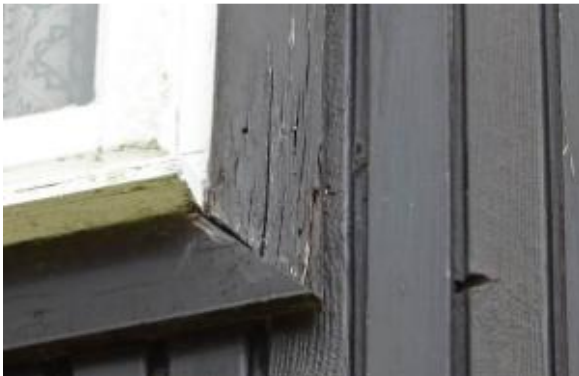
T15 – 3 Bushey Beeches, The Camp. Front first floor window, rot to architrave

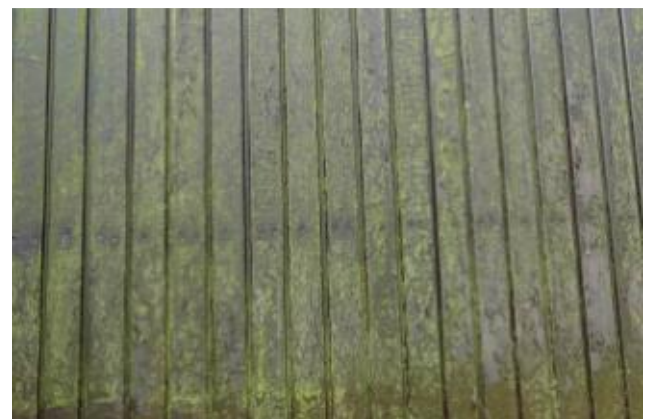
T18 – 3 Bushey Beeches, The Camp. Side elevation, algae growth on outer boards

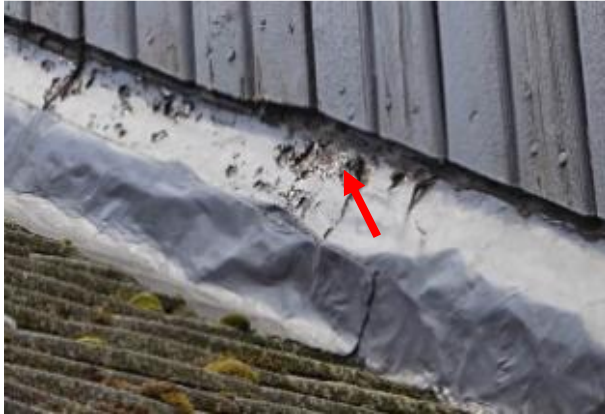
T19 – 3 Bushey Beeches, The Camp. Flashing at junction of Outbuilding & main house. Original flashing covered by “flashband” type repair, starting to disintegrate (arrowed)

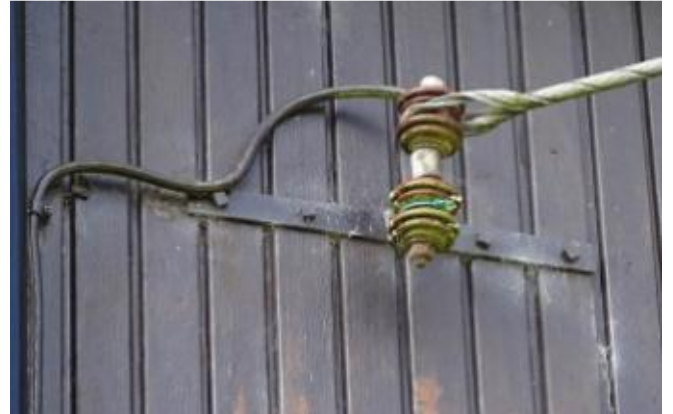
T20 – 3 Bushey Beeches, The Camp. Incoming mains electrics on side elevation

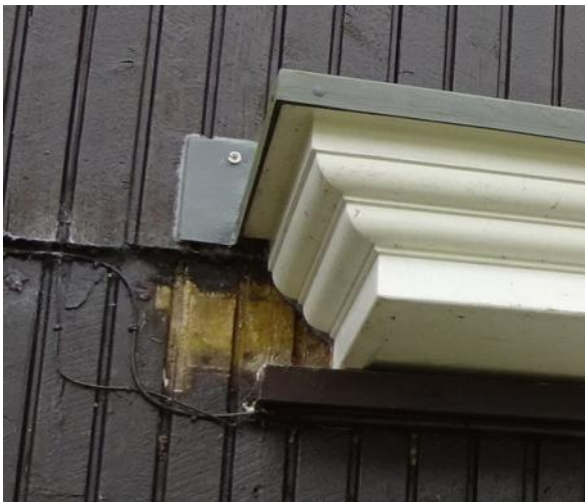
T21 – 6 The Knoll, Uley. Front, replacement canopy leaves untreated timber outer boards

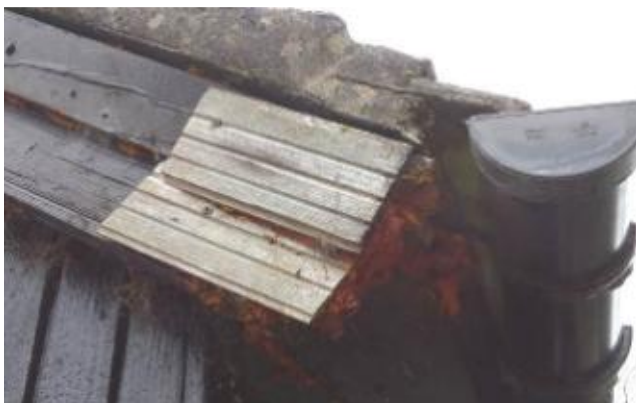
T23 – 6 The Knoll, Uley. Outbuilding roof, poor repair to verge fascia at eaves

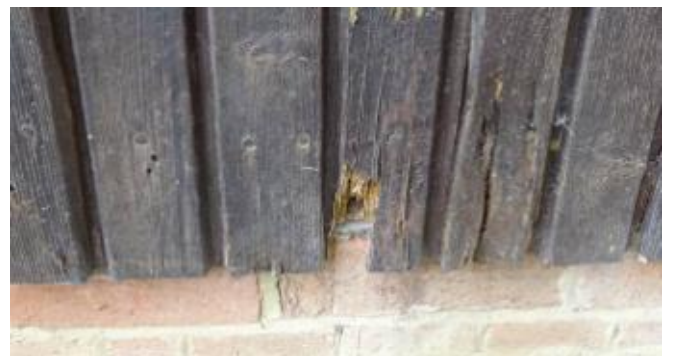
T24 – 6 The Knoll, Uley. Side, rot & woodworm to outer boards at dpc level

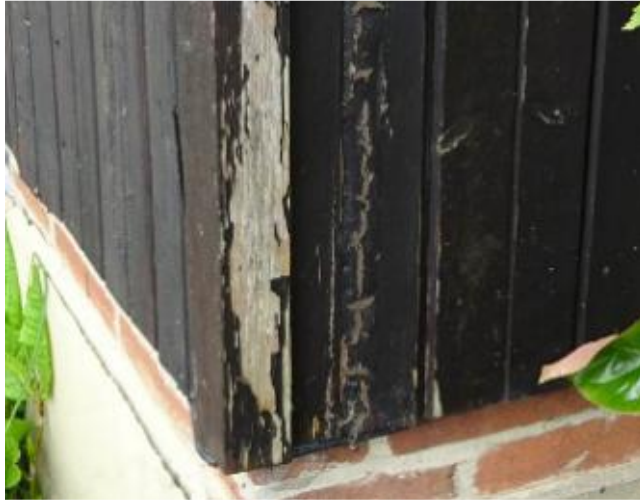
T25 – 6 The Knoll, Uley. Rear, rot to bay window corner architrave

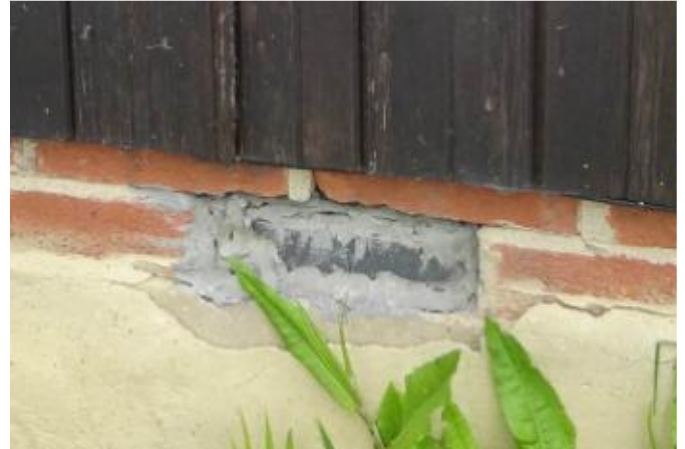
T26 – 6 The Knoll, Uley. Rear, blocked off vent to underfloor void

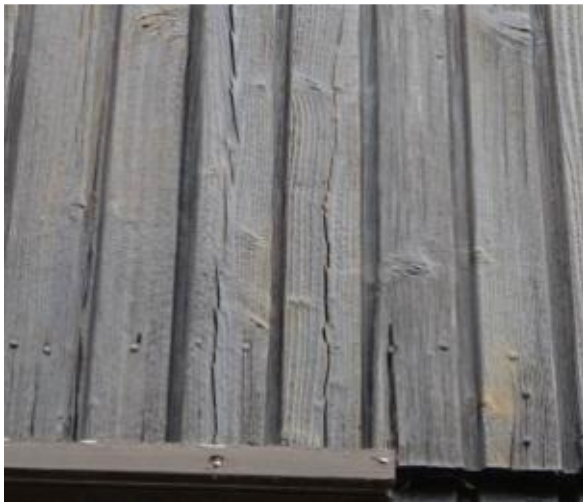
T27 – 6 The Knoll, Uley. Rear, example of rot & split outer boards above patio doors

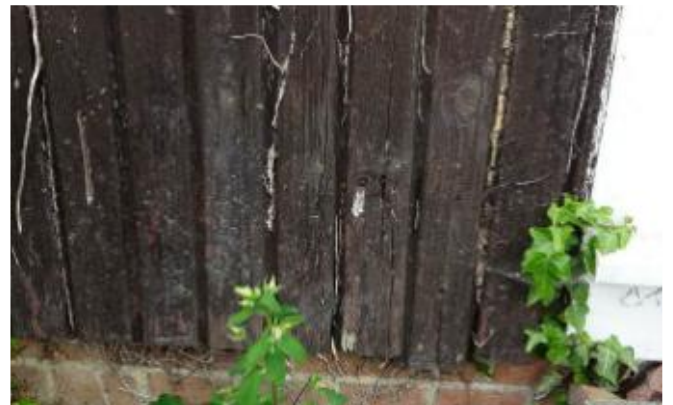
T28 – 6 The Knoll, Uley. Rear, example of rot & split outer boards near party wall

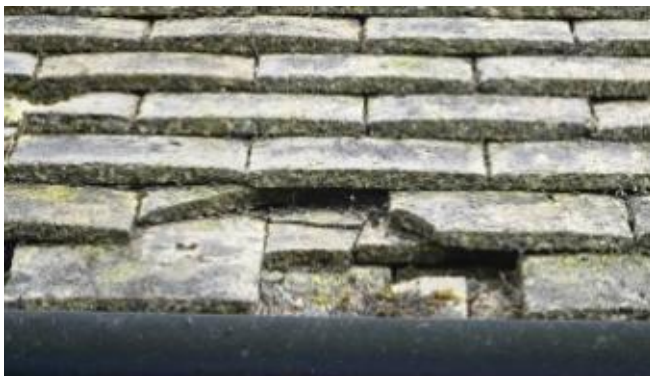
T29 – 8 The Knoll, Uley. Outbuilding front, slipped & missing roof tiles

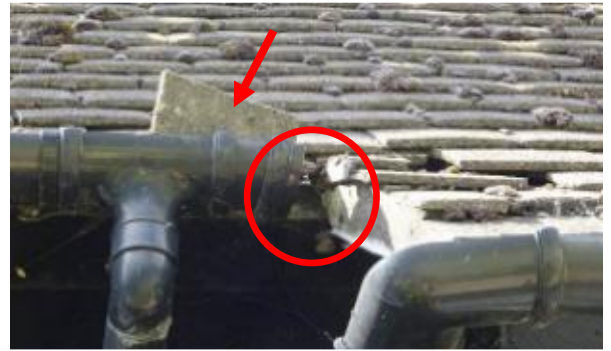
T38 – 7 Mount Pleasant, Wotton-Under-Edge. Rear slipped tiles (arrowed) & gap between gutter & roof (circled)
