Non-Traditional Homes Summary Property Review

Prepared for:
Stroud District Council
Council Offices
Ebley Mill
Ebley Wharf
STROUD
Gloucestershire
GL5 4UB

February 2018

Condition Survey

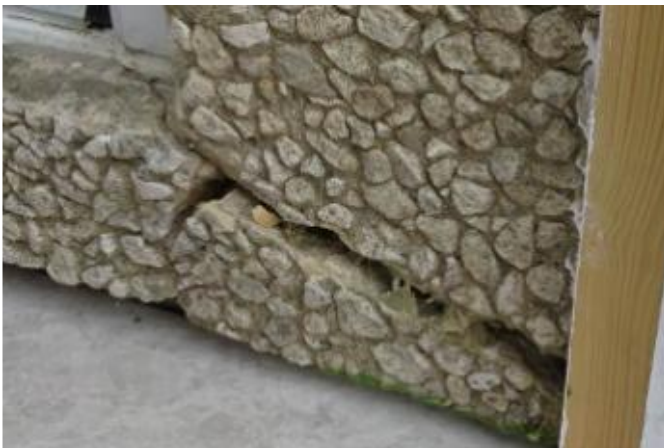
Q9 – 6 Badgers Way, Forest Green, broken panel section to right of front door (within porch)

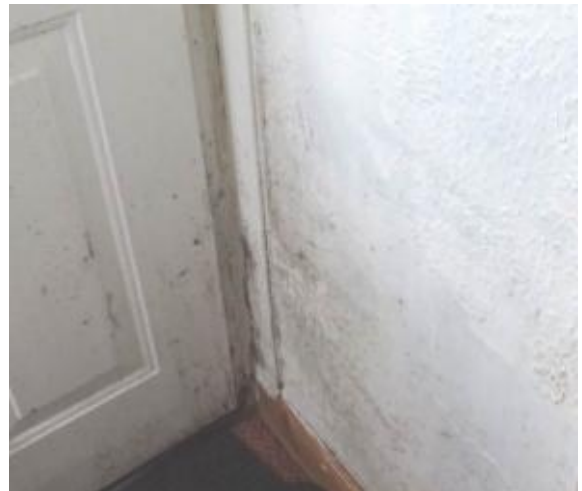
Q10 – 3 Nortonwood, Forest Green, mould in single storey entrance porch

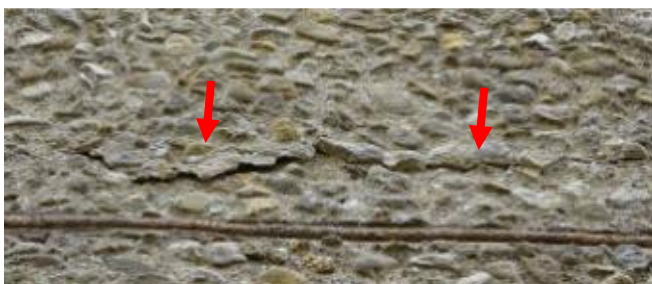
S23 – 18 Lawnside, Forest Green, crack/spall on
gable elevation just above eaves level

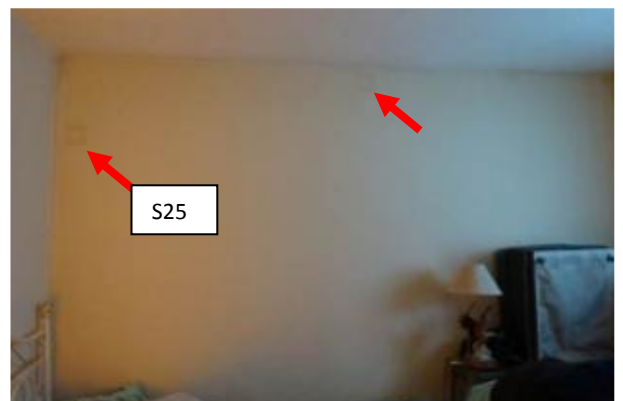
S24 – 45 Lawnside, Forest Green, bedroom gable
wall, two small square areas of staining
(arrowed). Photo S26 is to the right side.

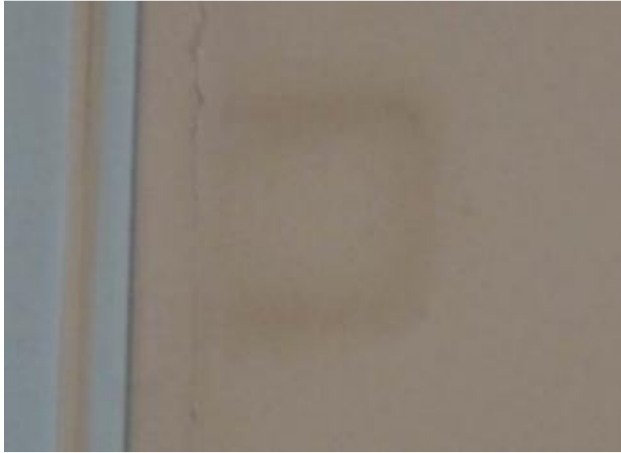
S25 – 45 Lawnside, Forest Green, bedroom gable wall, left hand staining detail

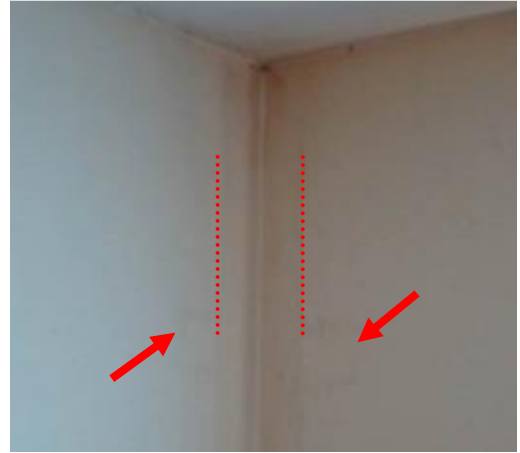
S26 – 45 Lawnside, Forest Green, bedroom gable rear corner, two vertical cracks (dotted), floor to ceiling, and two small stains (arrowed)

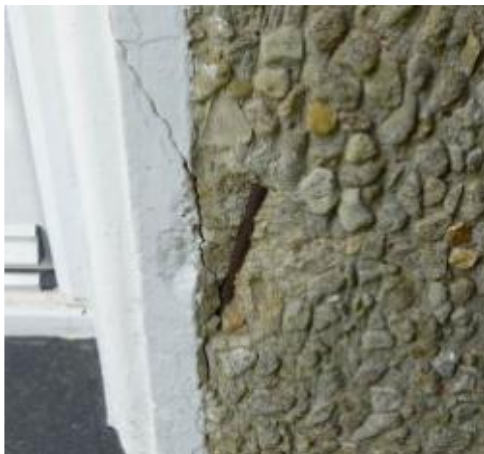
S27 – 56 Lawnside, Forest Green, front spalling to right of front door. Corroded steel & crack

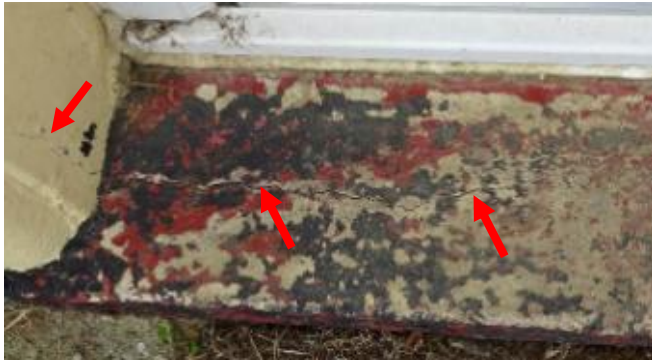
S31 – 51/52 Mankley Road, Leonard Stanley. Crack on door step extending up onto reveal

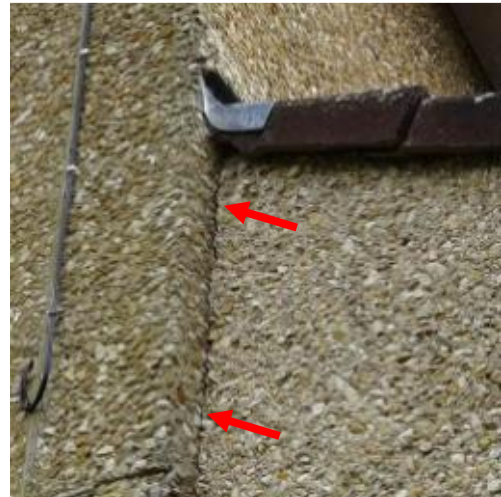
S40 – 6 Upper Park Road, Nailsworth. Cracking at junction of side extension & main house

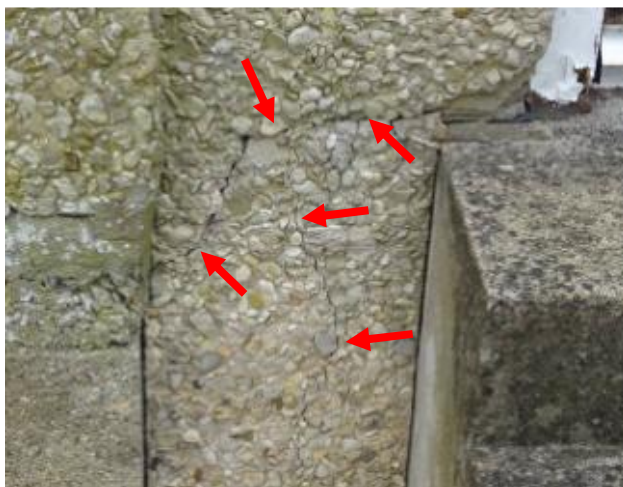
S41 – 6 Upper Park Road, Nailsworth. Cracking at dpc to side of door

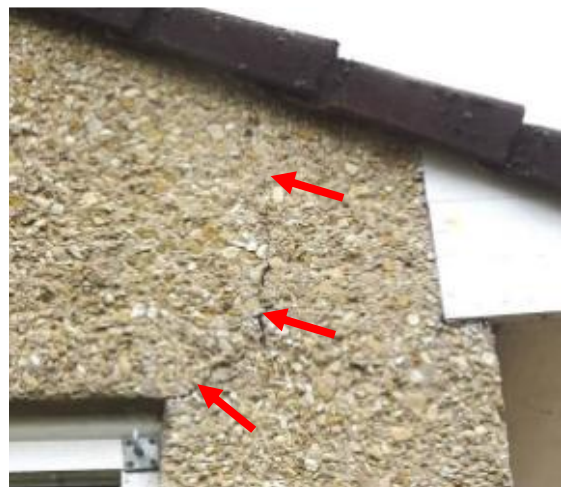
S42 – 6 Upper Park Road, Nailsworth. Cracking above door

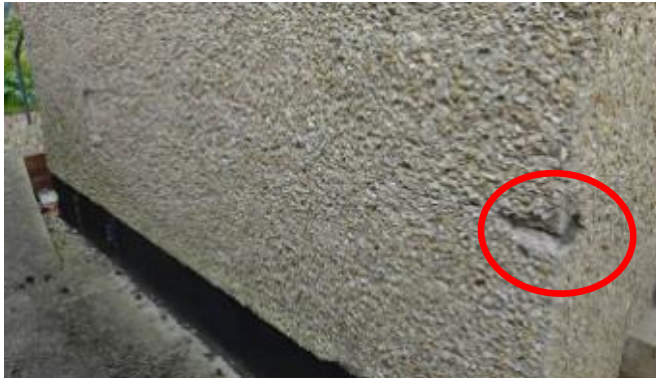
S43 – 6 Upper Park Road, Nailsworth. Side extension, cracking at dpc level

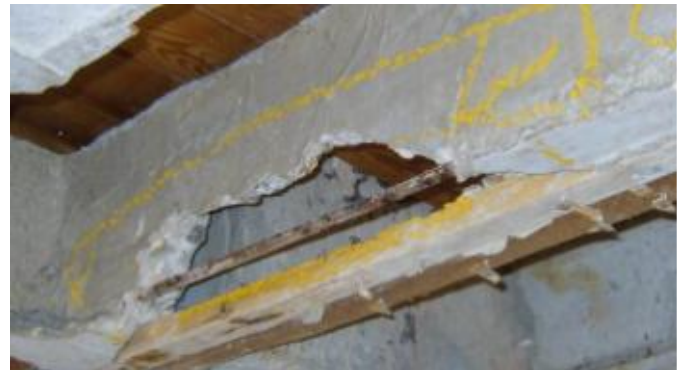
S50 – Typical PRC beam defect (not taken in SDC stock)

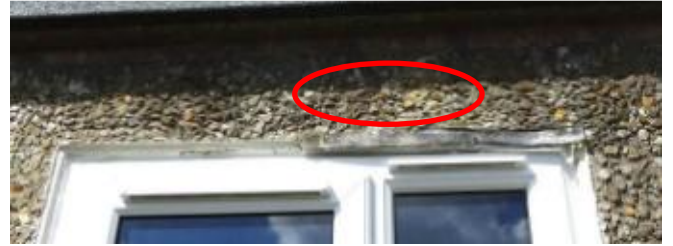
S62 – 31 Victory Road, Whiteshill. Side extension cracking above window (S63 circled)

- Amend database to correct additions and deletions found during the survey
- Install EWI, inspect **all** properties and carry out repairs to the PRC in advance.
- Install “whole house” ventilation system in conjunction with EWI.
- Check for and seal gaps across the party walls where there is a risk of fire spread.
- Check “ladder” FF beams at all changes of tenancy.
- Repairs to single storey extension at 31 Victory Road, Whiteshill

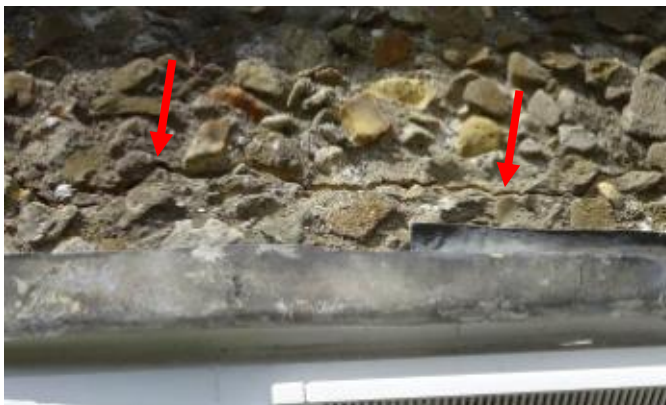
S63 – 31 Victory Road, Whiteshill. Side extension cracking above window detail

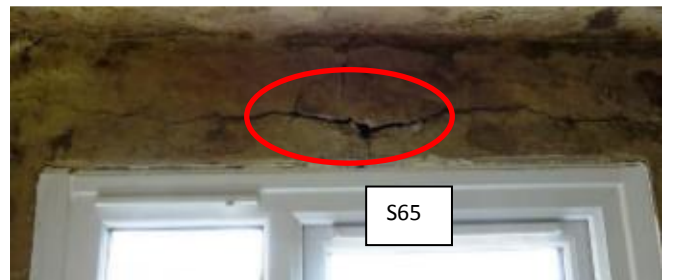
S64 – 31 Victory Road, Whiteshill. Side extension cracking above window viewed internally

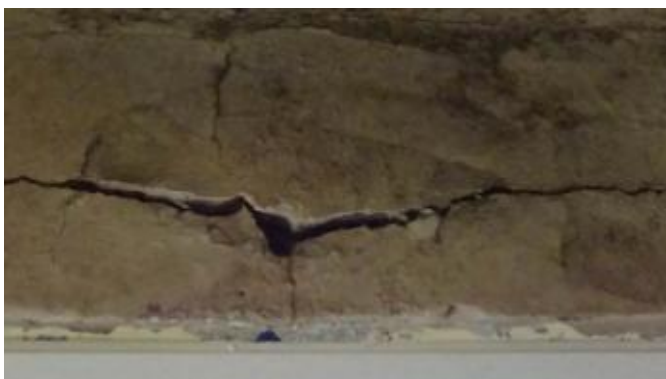
S65 – 31 Victory Road, Whiteshill. Side extension cracking above window viewed internally, detail

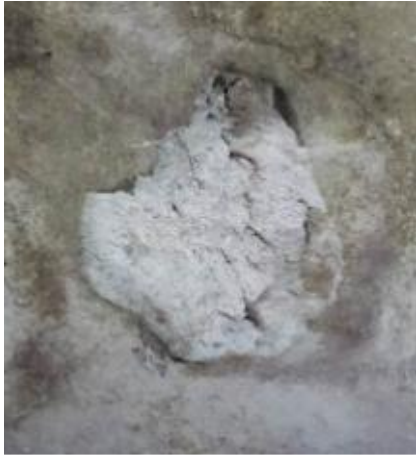
S67 – 31 Victory Road, Whiteshill. Side extension spalling concrete to ceiling

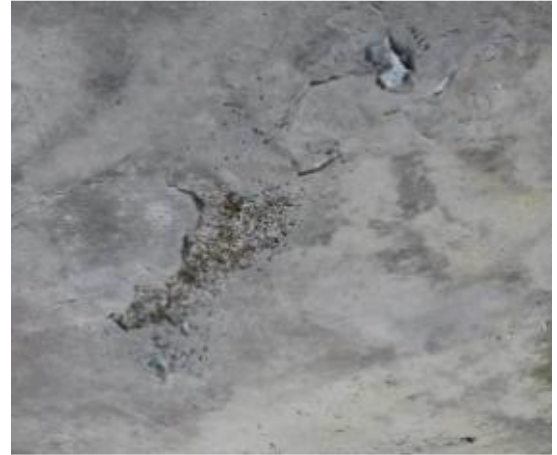
S68 – 31 Victory Road, Whiteshill. Side extension poor finishes to ceiling

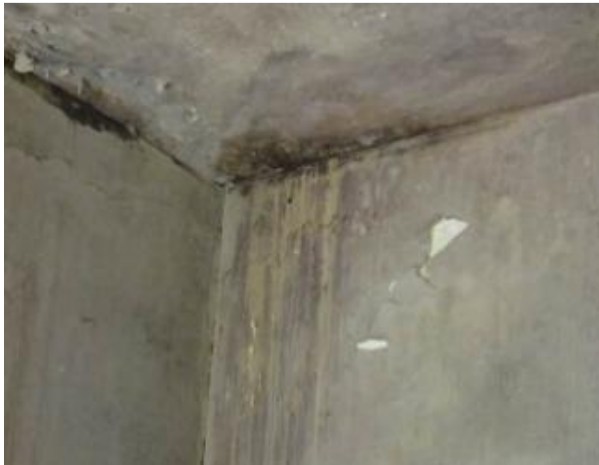
S69 – 31 Victory Road, Whiteshill. Side extension mould & damp ingress staining in front corner

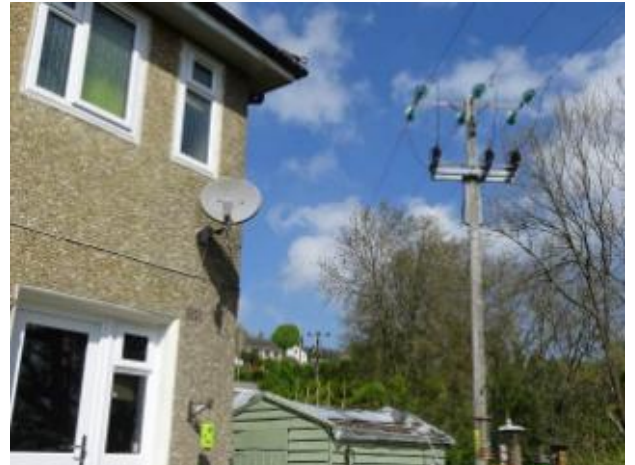
S70 – 26 Victory Road, Whiteshill. Power lines close to the building

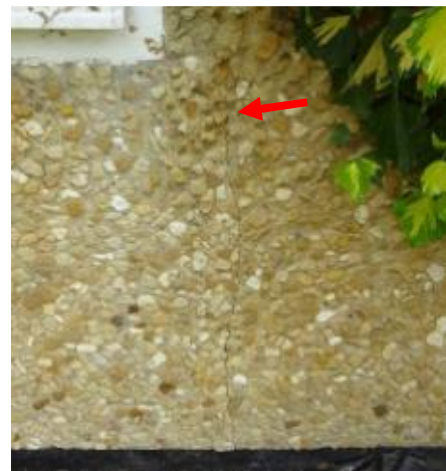
S71 – High Field, crack under front window

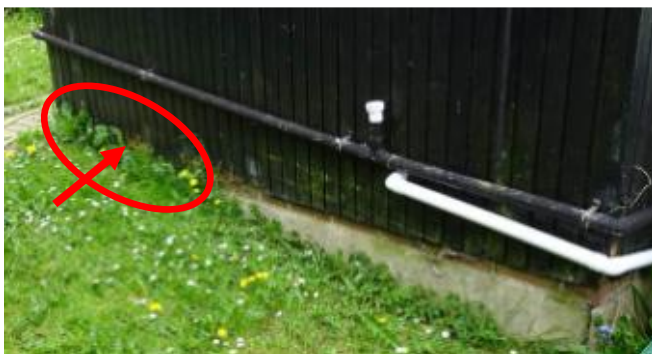
T9 – 32 Barrs Lane, North Nibley. Outbuilding side, ground level too high (circled). Rot to outer boards at dpc level (T10 circled)

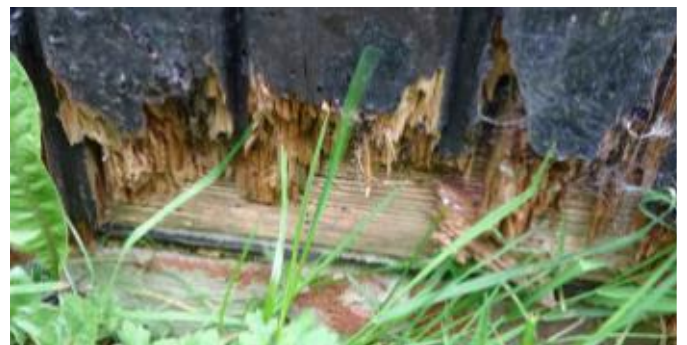
T10 – 32 Barrs Lane, North Nibley. Outbuilding side, rotten timber outer boards & keel plate

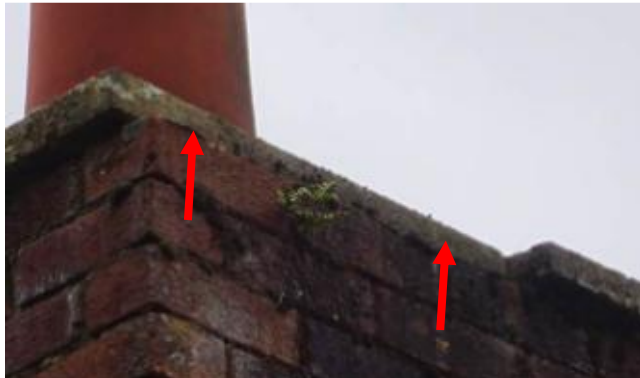
T13 – 32 Barrs Lane, North Nibley. Rear party wall chimney capping broken away (arrowed)

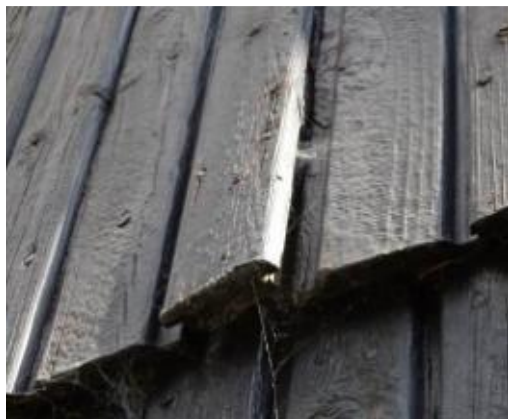
T17 – 3 Bushey Beeches, The Camp. First floor outer boards, board “sprung” due to failed fixing

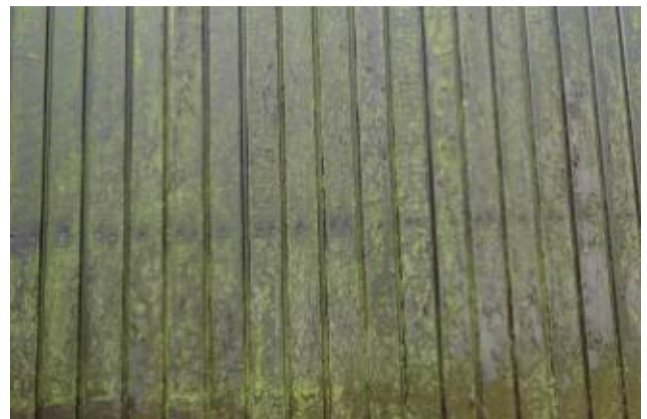
T18 – 3 Bushey Beeches, The Camp. Side elevation, algae growth on outer boards

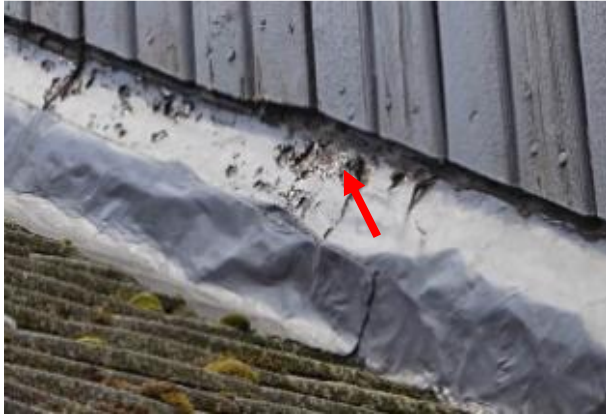
T19 – 3 Bushey Beeches, The Camp. Flashing at junction of Outbuilding & main house. Original flashing covered by “flashband” type repair, starting to disintegrate (arrowed)

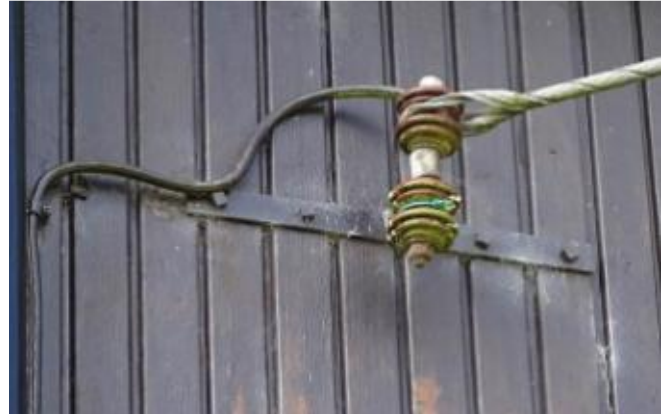
T20 – 3 Bushey Beeches, The Camp. Incoming mains electrics on side elevation

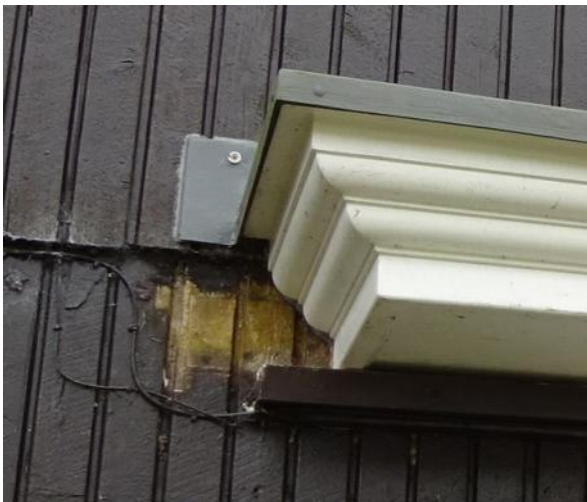
T21 – 6 The Knoll, Uley. Front, replacement canopy leaves untreated timber outer boards

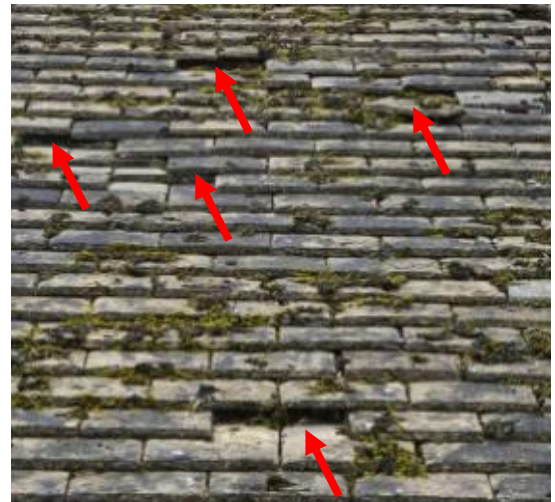
T22 – 6 The Knoll, Uley. Outbuilding front roof, slipped & missing tiles

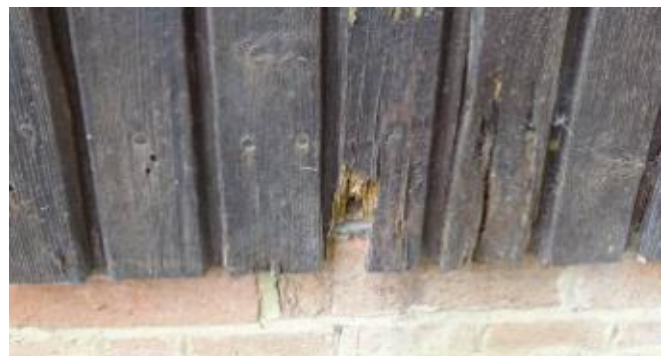
T24 – 6 The Knoll, Uley. Side, rot & woodworm to outer boards at dpc level

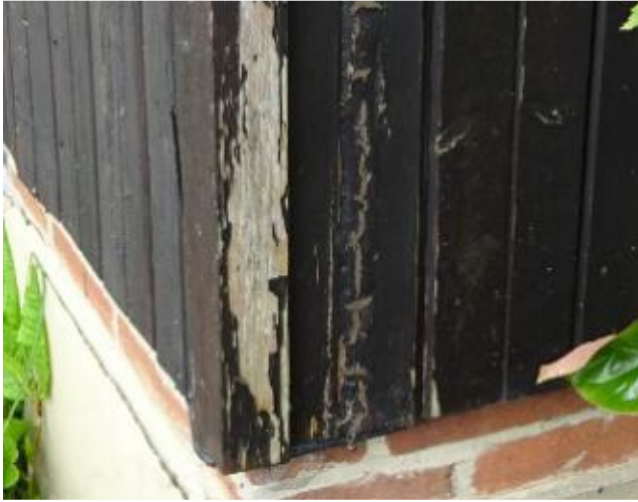
T25 – 6 The Knoll, Uley. Rear, rot to bay window corner architrave

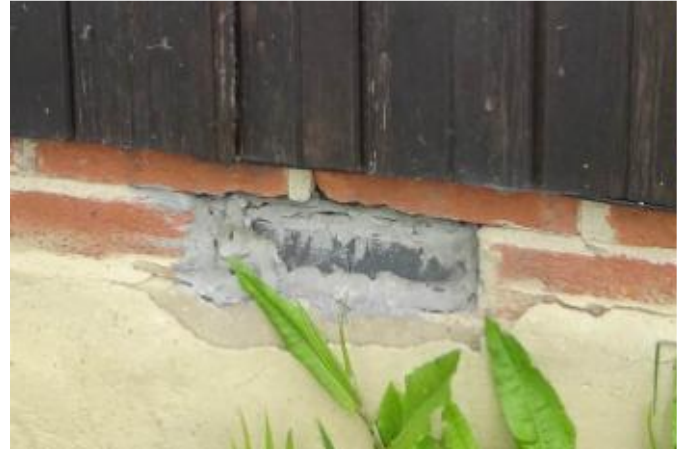
T26 – 6 The Knoll, Uley. Rear, blocked off vent to underfloor void

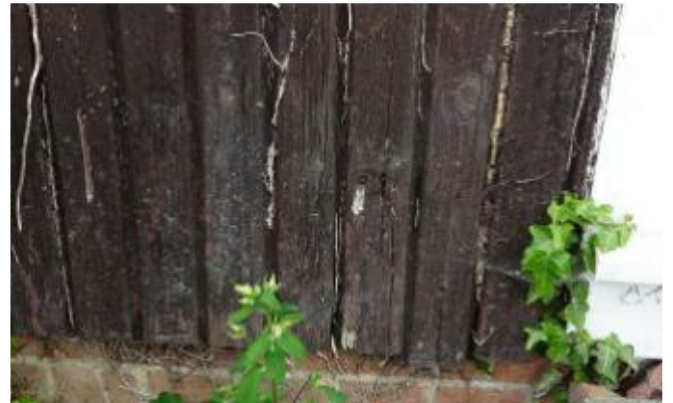
T28 – 6 The Knoll, Uley. Rear, example of rot & split outer boards near party wall

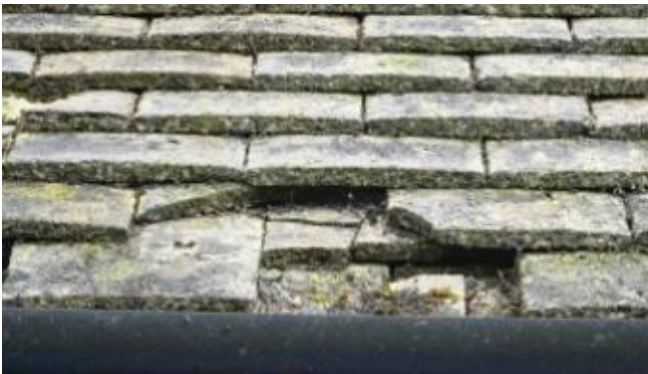
T29 – 8 The Knoll, Uley. Outbuilding front, slipped & missing roof tiles

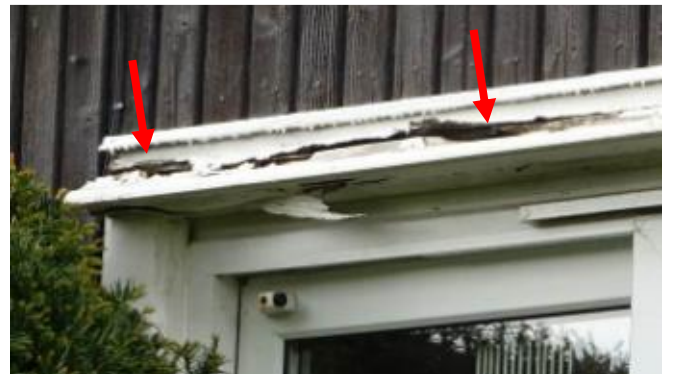
T30 – 8 The Knoll, Uley. Rear, rotten timber architrave above patio doors

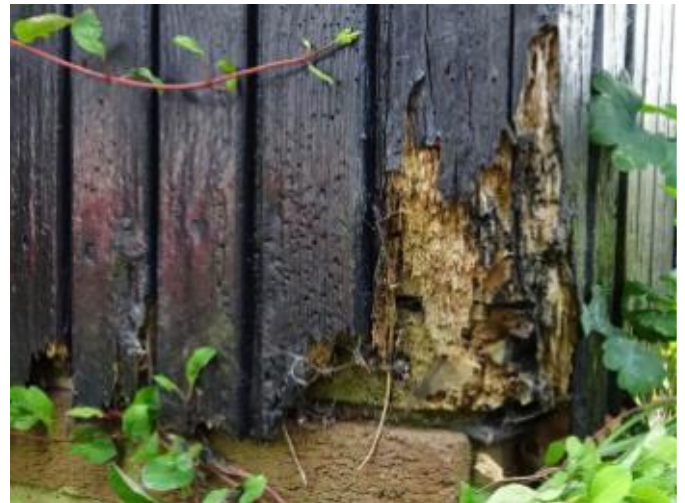
T32 – 3 Mount Pleasant, Wotton-Under-Edge. Front corner, rot & woodworm to outer boards & keel plate.

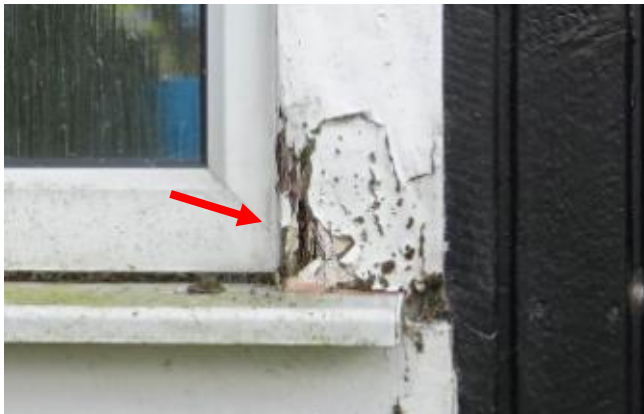
T33 – 3 Mount Pleasant, Wotton-Under-Edge. Side, rot to window architrave

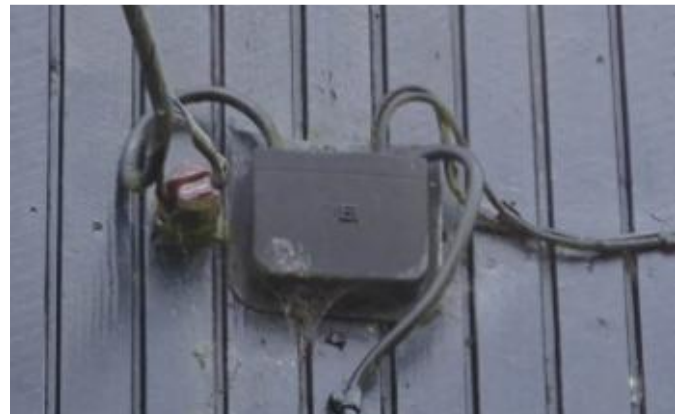
T34 – 3 Mount Pleasant, Wotton-Under-Edge. Incoming mains electrics on side elevation

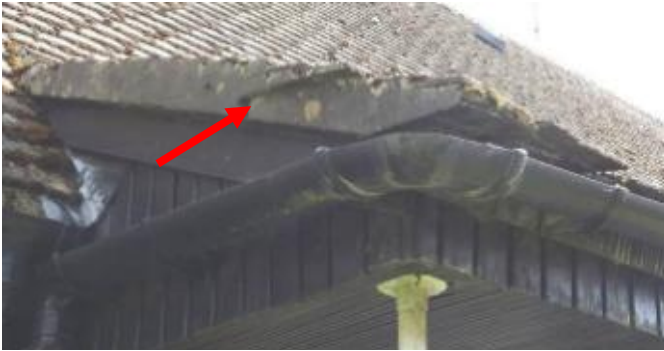
T37 – 7 Mount Pleasant, Wotton-Under-Edge. Front porch, cracking at verge (arrowed)
