## Condition Survey

**Airey  
BL8  
Cornish  
Dorlonco  
Reema Conclad  
Reema Hollow Panel  
Stent  
Swedish  
Unity  
Woolaway**

## **dwellings at various locations**

By Curtins Consulting Ltd  
May 2017

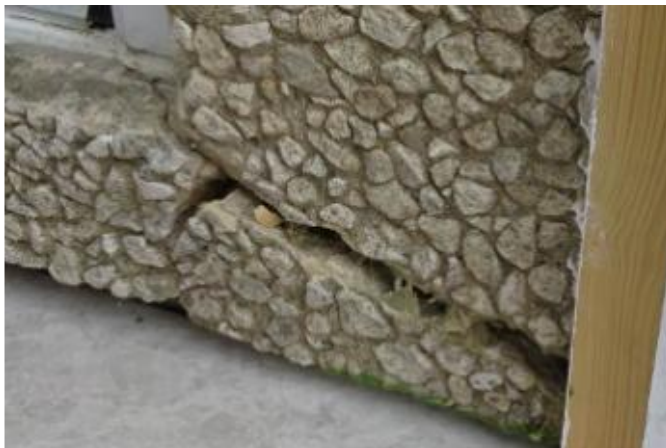
Q9 – 6 Badgers Way, Forest Green, broken panel section to right of front door (within porch)

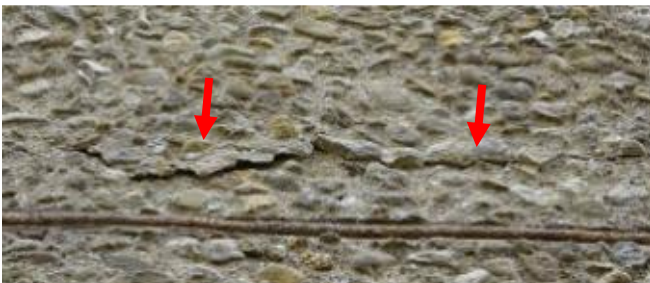
S23 – 18 Lawnside, Forest Green, crack/spall on  
gable elevation just above eaves level

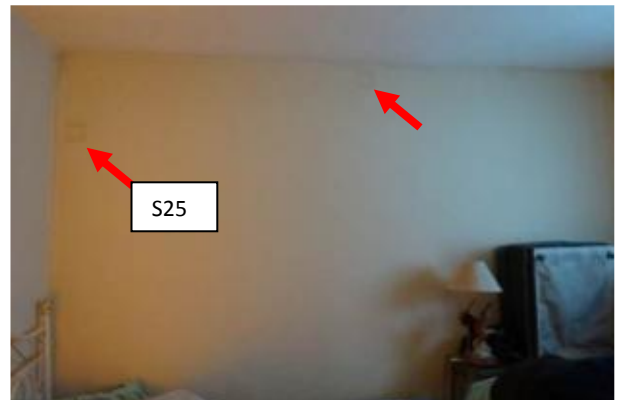
S24 – 45 Lawnside, Forest Green, bedroom gable  
wall, two small square areas of staining  
(arrowed). Photo S26 is to the right side.

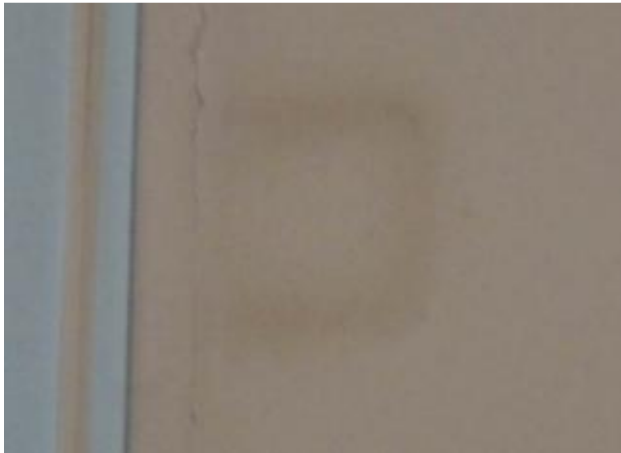
S25 – 45 Lawnside, Forest Green, bedroom gable wall, left hand staining detail

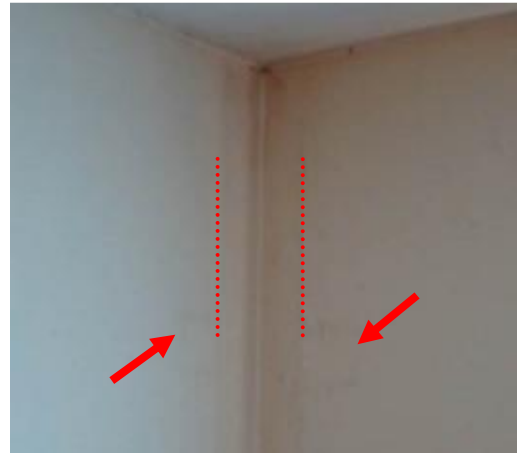
S26 – 45 Lawnside, Forest Green, bedroom gable rear corner, two vertical cracks (dotted), floor to ceiling, and two small stains (arrowed)

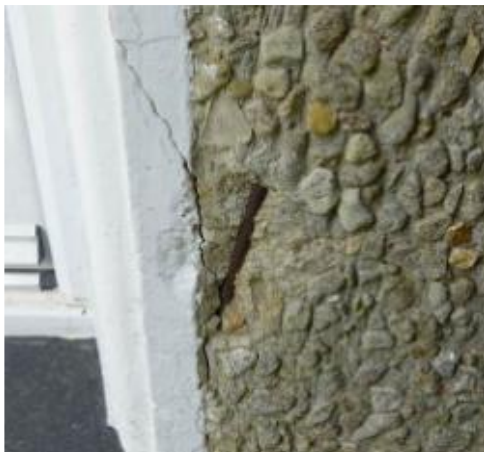
S27 – 56 Lawnside, Forest Green, front spalling to right of front door. Corroded steel & crack

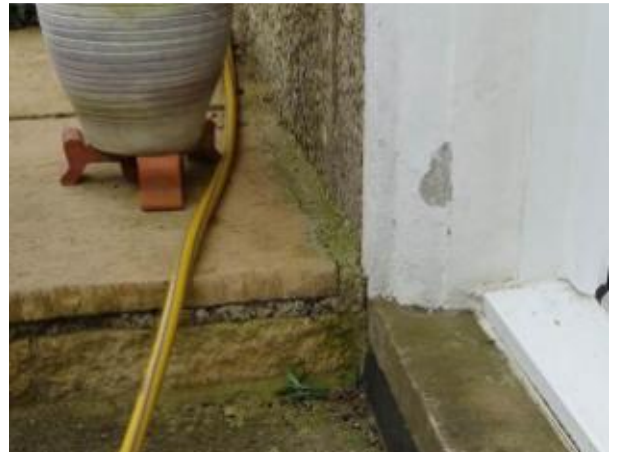
S28 – 18 Lawnside, Forest Green, paving to left of front door too high

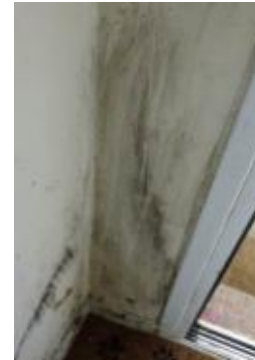
S32 – 51/52 Mankley Road, Leonard Stanley. Mould on external wall at bottom of stairs to first floor flat.

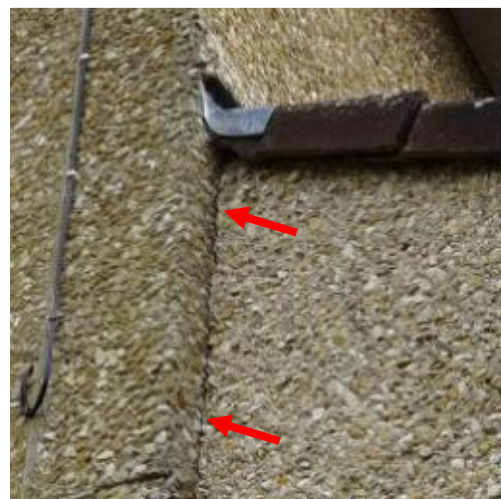
S40 – 6 Upper Park Road, Nailsworth. Cracking at junction of side extension & main house

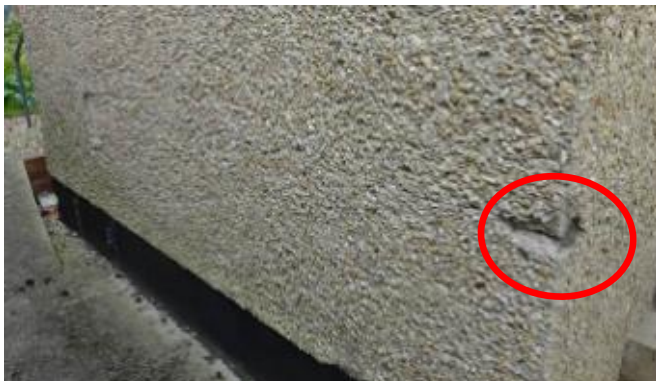
S43 – 6 Upper Park Road, Nailsworth. Side extension, cracking at dpc level

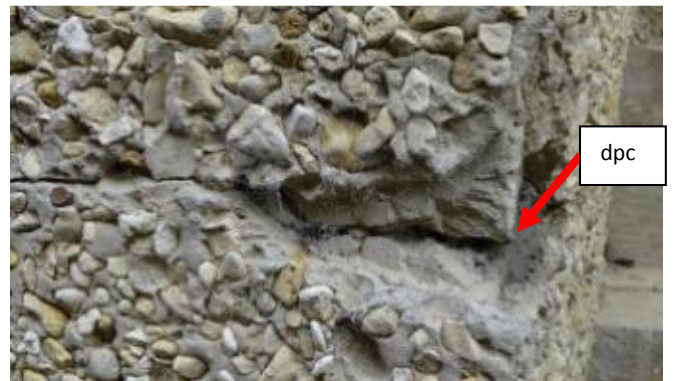
S44 – 6 Upper Park Road, Nailsworth. Side extension, cracking at dpc level detail

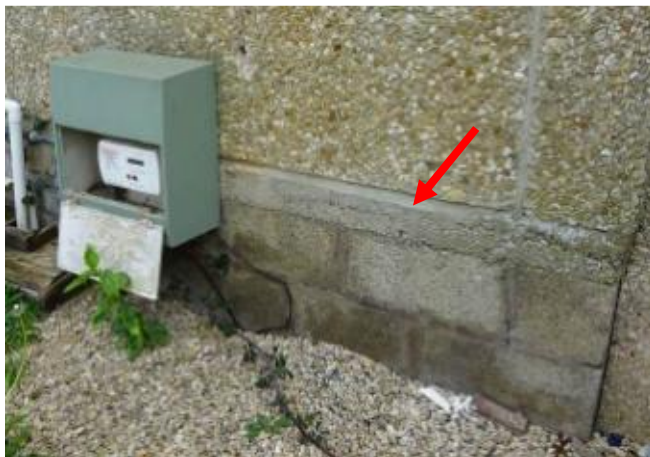
S45 – 6 Upper Park Road, Nailsworth. Rear corner main house. Cast in-situ concrete (arrowed) & blockwork suggests underpinning

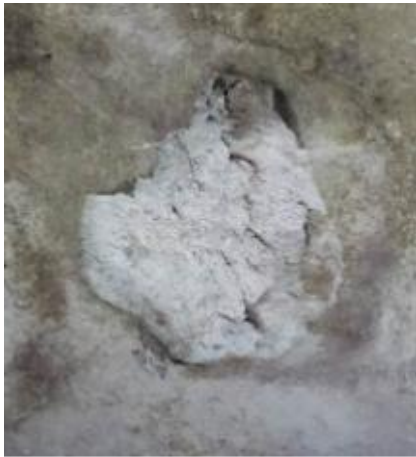
S67 – 31 Victory Road, Whiteshill. Side extension spalling concrete to ceiling

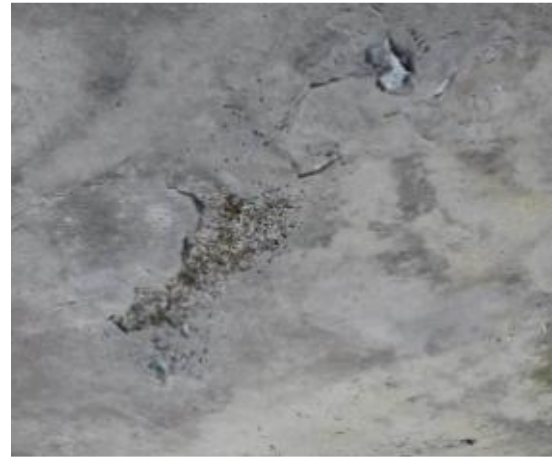
S68 – 31 Victory Road, Whiteshill. Side extension poor finishes to ceiling

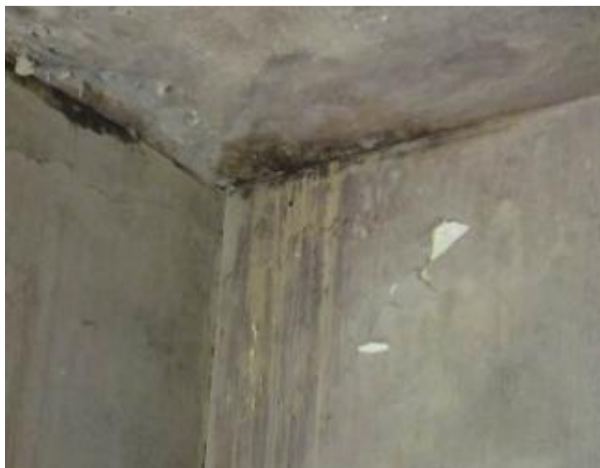
S69 – 31 Victory Road, Whiteshill. Side extension mould & damp ingress staining in front corner

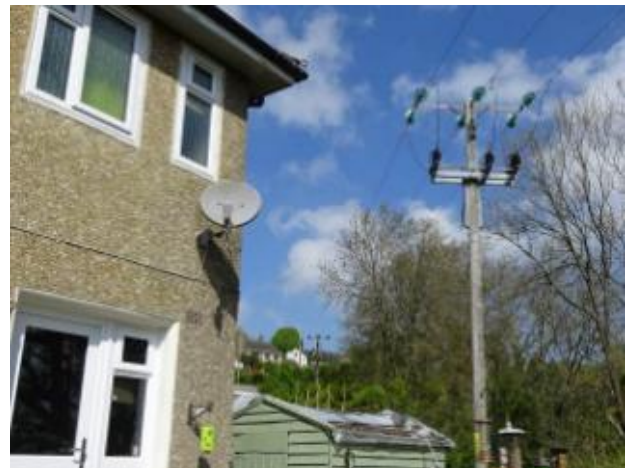
S70 – 26 Victory Road, Whiteshill. Power lines close to the building

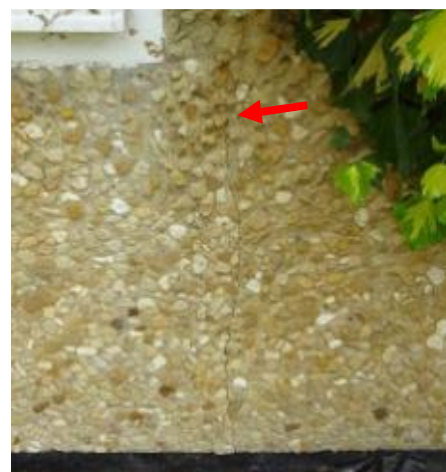
S71 – High Field, crack under front window

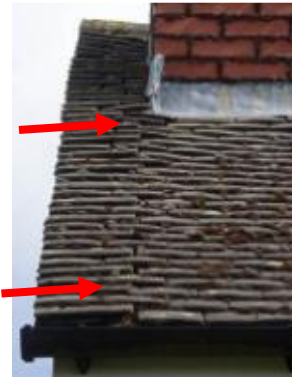
T14 – 3 Bushey Beeches, The Camp. Distortion of roof tiles on line below chimney (arrowed)

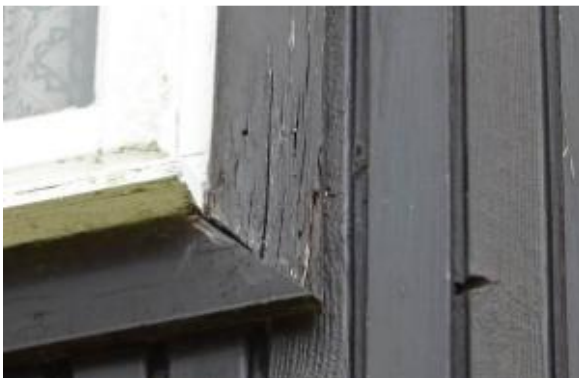
T15 – 3 Bushey Beeches, The Camp. Front first floor window, rot to architrave

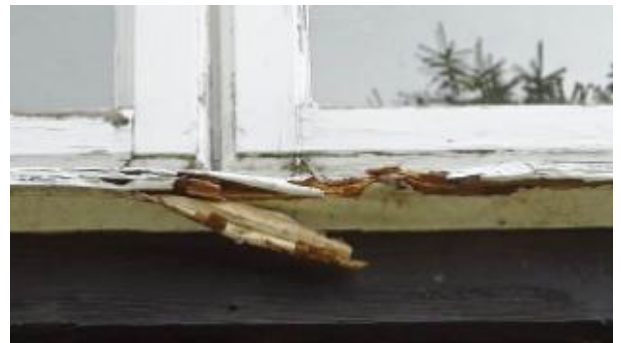
T16 – 3 Bushey Beeches, The Camp. First floor window, rot to window cill

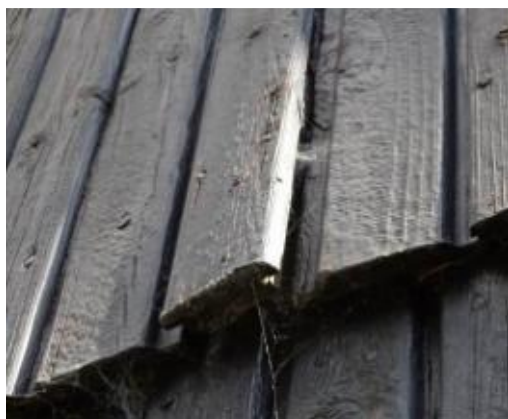
T17 – 3 Bushey Beeches, The Camp. First floor outer boards, board "sprung" due to failed fixing

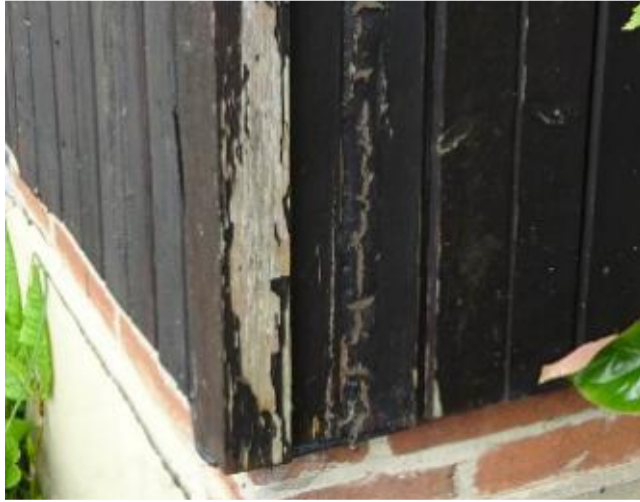
T25 – 6 The Knoll, Uley. Rear, rot to bay window corner architrave

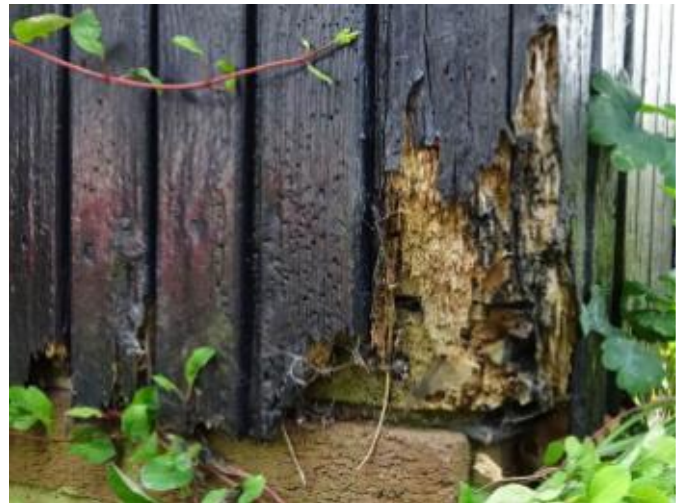
T32 – 3 Mount Pleasant, Wotton-Under-Edge. Front corner, rot & woodworm to outer boards & keel plate.
