## **St Mary's, Eastcombe, Stroud**

### **Arboricultural Report containing:**

*Prepared by:*  
[REDACTED] **M.Arbor.A, Tech. Cert. (Arbor. A.)**  
**Arboricultural Consultant**  
**February 2021**  
**Revised May 2021**

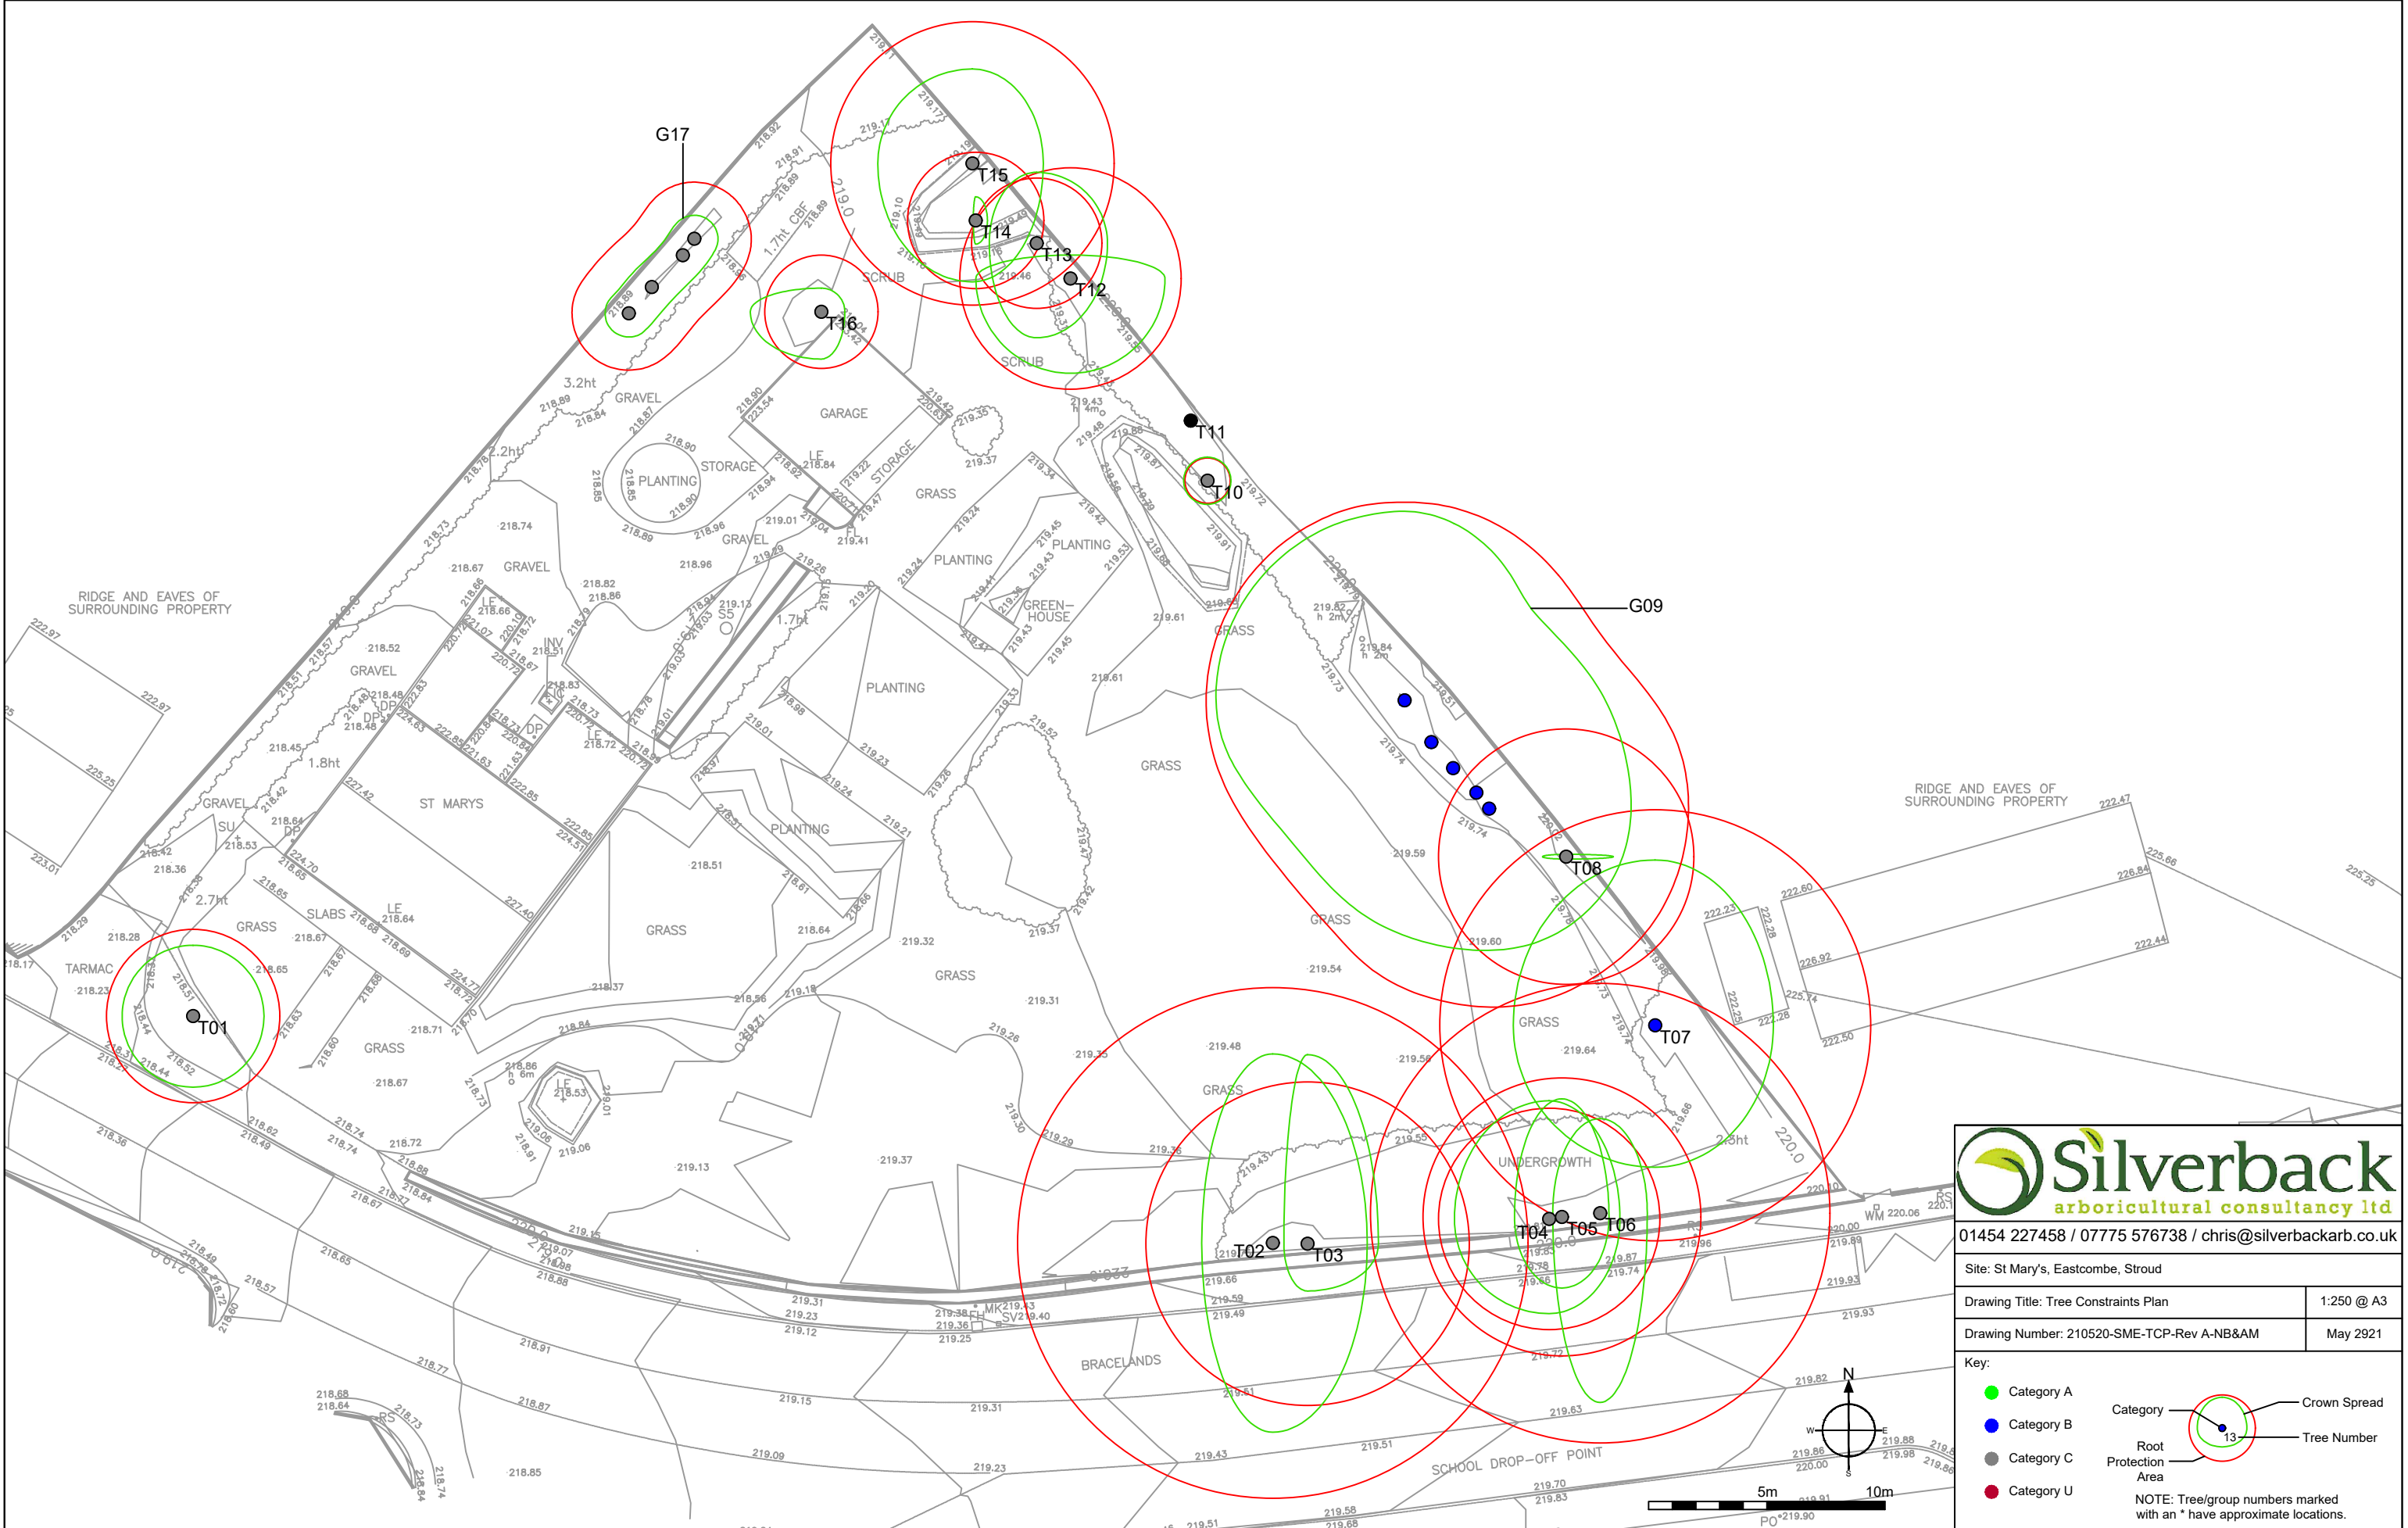
Drawing Number: 210520-SME-TCP-Rev A-NB&AM	May 2021
--	----------

- 6.3 The Tree Constraints Plan (TCP), (appendix 2), shows the Root Protection Areas (RPAs) for the individual trees identified in the tree schedule tables. This represents the minimum area in m<sup>2</sup> which ideally, should be left undisturbed around each tree were it to be retained. The TCP also shows a representation of the crown spread of each tree measured in four cardinal directions. The RPA has been calculated in accordance with Section 4.6 of BS5837:2012 Trees in relation to design, demolition and construction – Recommendations.

The Root Protection Areas (RPAs) of the remaining trees along the southern and eastern boundary extend across a large section of the southeast area of the site. It is considered that the construction of any new access should be positioned outside the calculated Root Protection Area of the remaining trees. Any new access which extends through the Root Protection Areas would need to be no-dig construction where it extends through the RPAs.
