HOUSING COMMITTEE

Non-Traditional Homes Summary Property Review

Prepared for:
Stroud District Council
Council Offices
Ebley Mill
Ebley Wharf
STROUD
Gloucestershire
GL5 4UB

Curtin's Consulting Limited were appointed by Stroud District Council (referred to in their report as SDC or the Council) to undertake a survey and prepare a report on the condition of the remaining non-traditional properties which remain with the Councils housing portfolio.

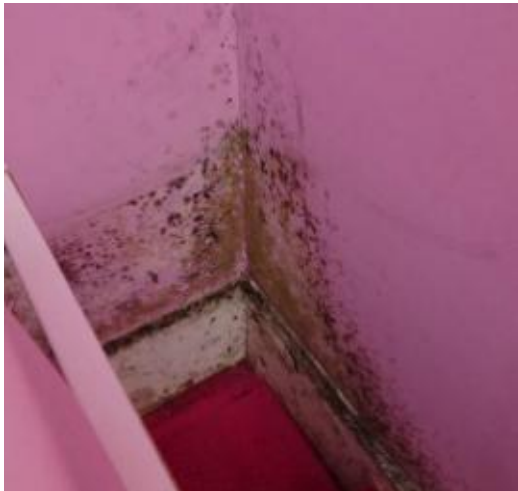
P7 – 14 Mosley Cresnet, Cashes Green, mould in front ground floor room used as bedroom

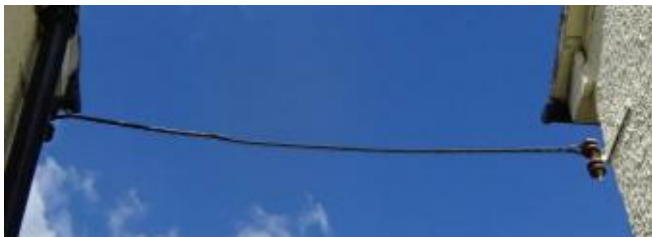
P9 – Typical overhead power supply cables between buildings (this one at 14 Mosley Cresnet, Cashes Green)

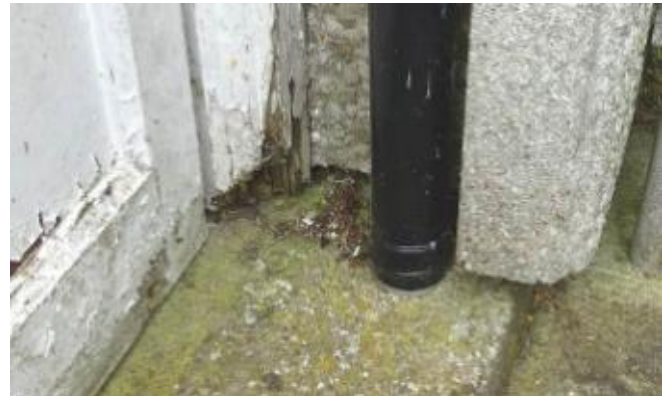
Q14 – Example of porch door close to rainwater downpipe & corner (problem with EWI)

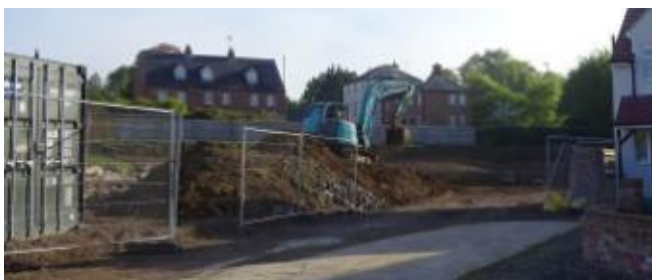
S15 – Site at Wharfedale Way, Bridgend, two Reema houses demolished (Nos 8 & 10)

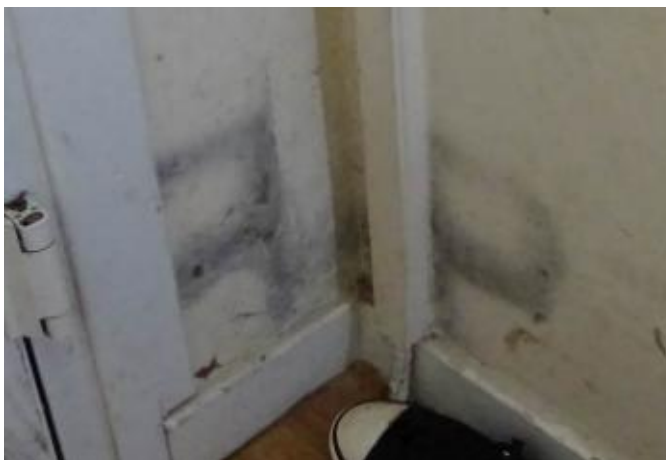
S17 – 12A Lawnside, Forest Green, Hall mould in square shapes on front & alleyway walls

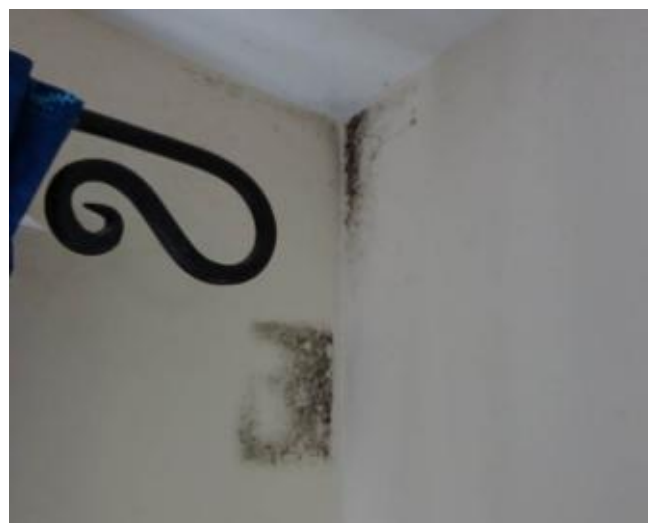
S18 – 12A Lawnside, Forest Green, Bedroom mould to right of window high level

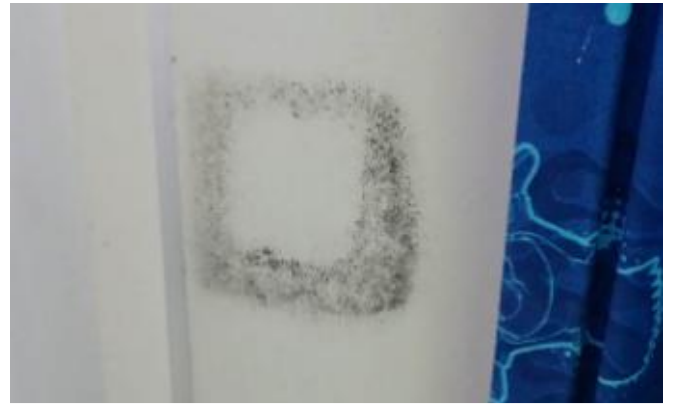
S20 – 12A Lawnside, Forest Green, Bedroom
mould to left of window mid height

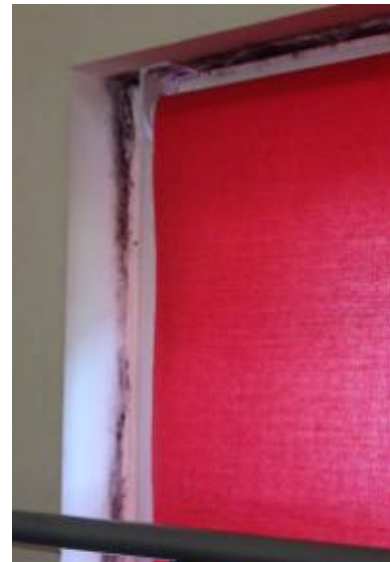
S22 – 12A Lawnside, Forest Green, Bedroom 2
mould on window reveal & head

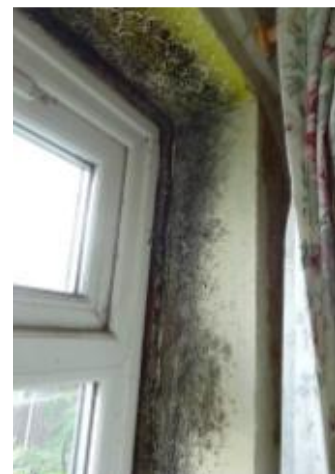
S30 – 39 Mankley Road, Leonard Stanley. Mould in window reveal at head (one of many windows affected)

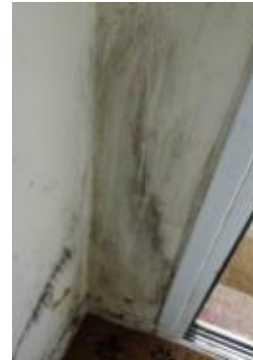
S32 – 51/52 Mankley Road, Leonard Stanley. Mould on external wall at bottom of stairs to first floor flat.

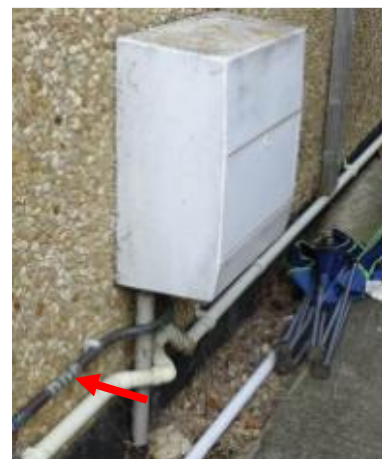
S34 – 39 Mankley Road, Leonard Stanley. Gas meter box & pipework

Note: Photographs S28, and S33 to S37 illustrate issues to be dealt with if EWI is installed; ground level too high, conservatories and covered ways, gas meters and pipework.

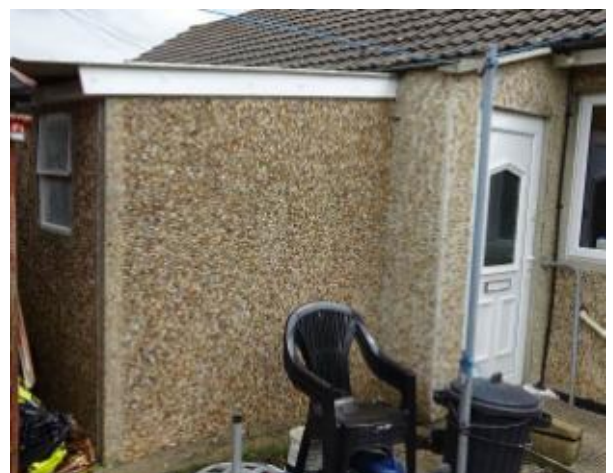
S36 – 38 Glebe Road, Minchinhampton. Outbuilding of Reema panel construction jointed to bungalow

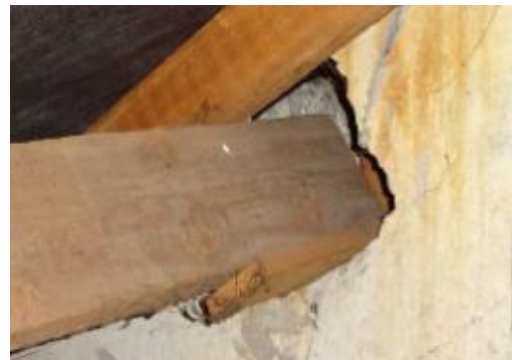
S52 – 3 Upper Park Road, Nailsworth. Roof purlin at party wall. Hole through to other side of wall, risk of fire spread.

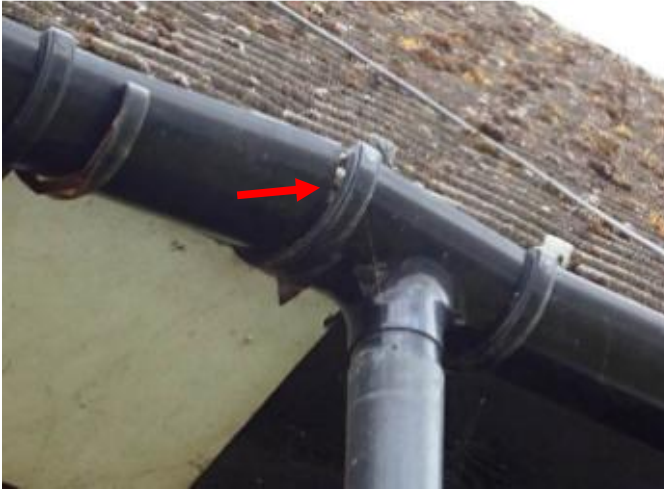
T7 – 32 Barrs Lane, North Nibley. Front gutter disconnected at downpipe bracket (arrowed)

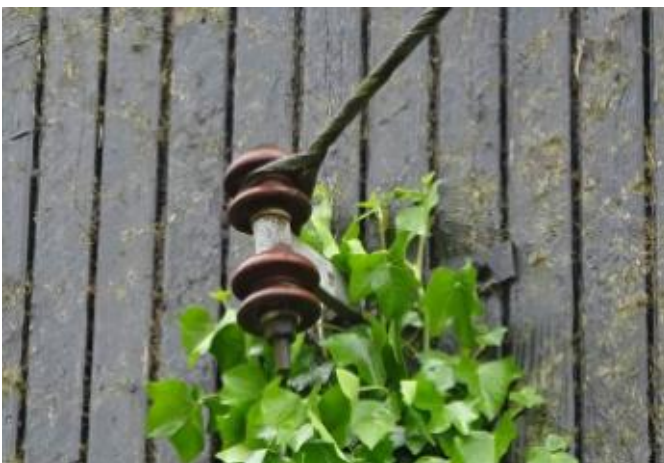
T11 – 32 Barrs Lane, North Nibley. Incoming mains electrics on side elevation

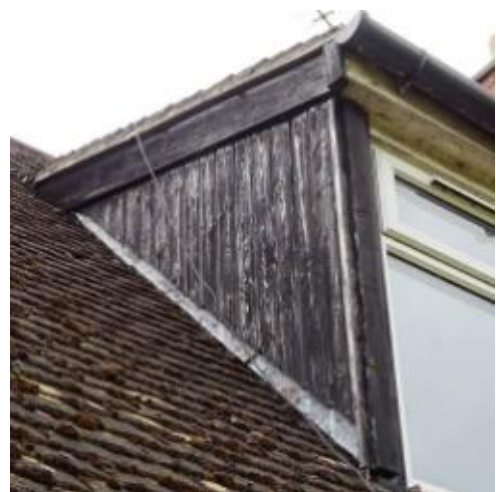
T12 – 32 Barrs Lane, North Nibley. Rear, poor timber to dormer side and architrave

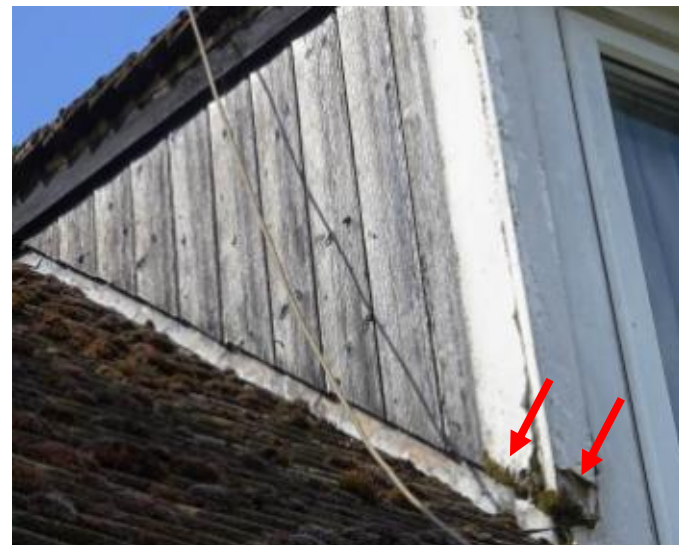
T40 – 7 Mount Pleasant, Wotton-Under-Edge. Rear, poor timber to dormer side, and architrave rotten near roof tiles (arrowed)
