Non-Traditional Homes Summary Property Review

Prepared for:
Stroud District Council
Council Offices
Ebley Mill
Ebley Wharf
STROUD
Gloucestershire
GL5 4UB

February 2018

Condition Survey

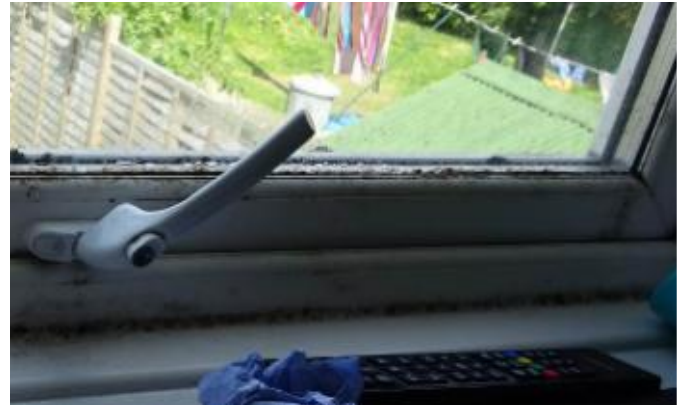
P8 – 14 Mosley Cresnet, Cashes Green, mould on window frame in rear bedroom

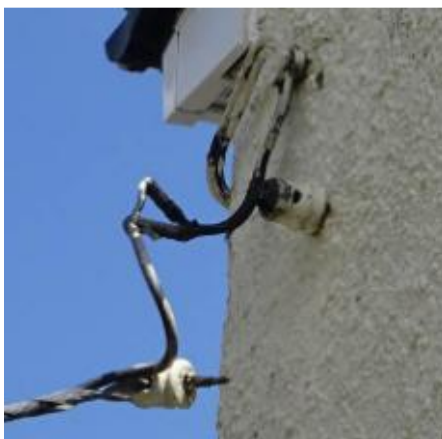
P11 – Overhead power supply fixing at wall, at 14 Hyett Road, Cashes Green

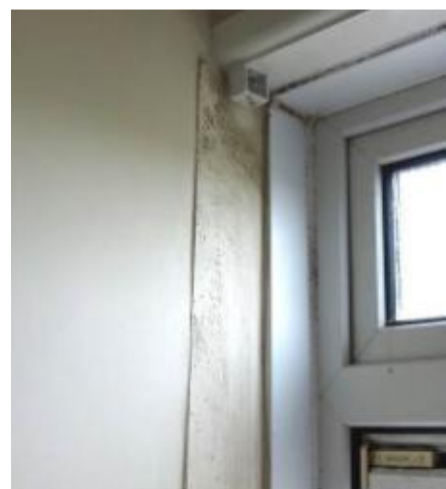
Q12 – 19 Nortonwood, Forest Green, mould in bathroom in window reveal

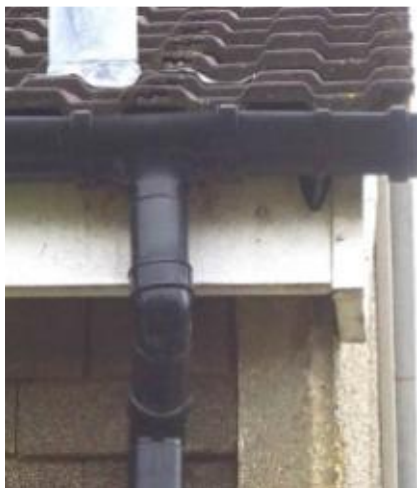
Q15 – Example of roof verge close to external wall (need to extend roof for EWI)

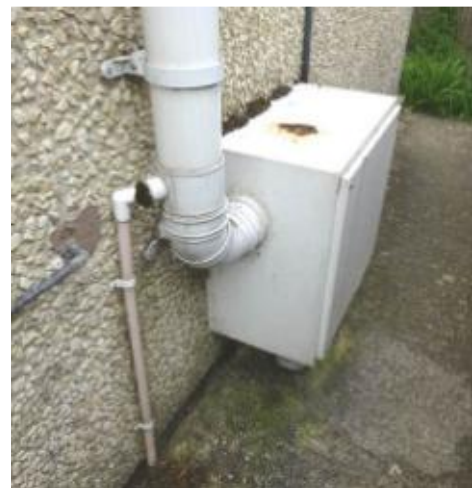
Q16 – Example of Radon Pump (to 1 No in Badgers Way, and 3 No in Woodpecker Way)

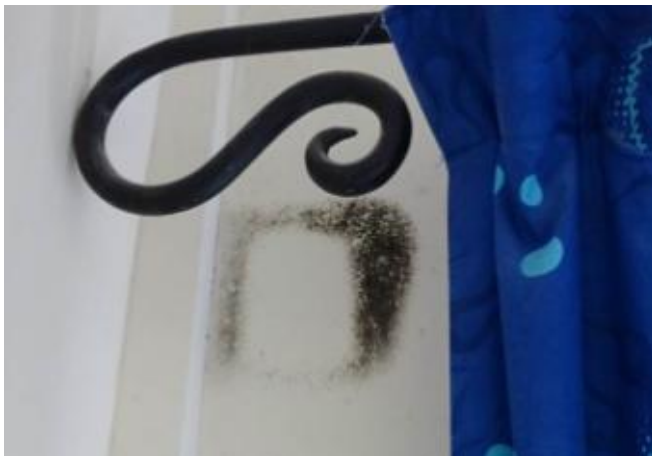
S19 – 12A Lawnside, Forest Green, Bedroom
mould to left of window high level

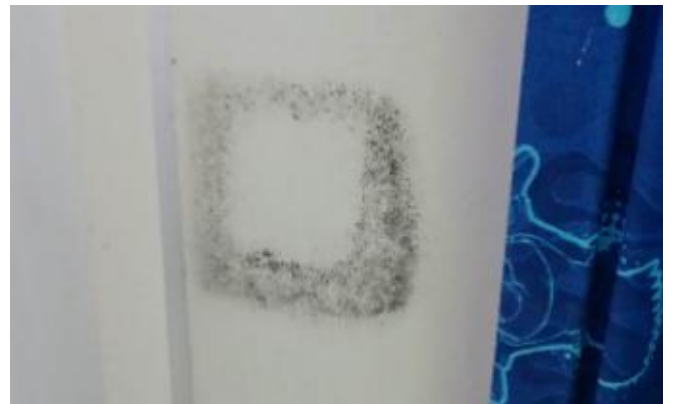
S20 – 12A Lawnside, Forest Green, Bedroom
mould to left of window mid height

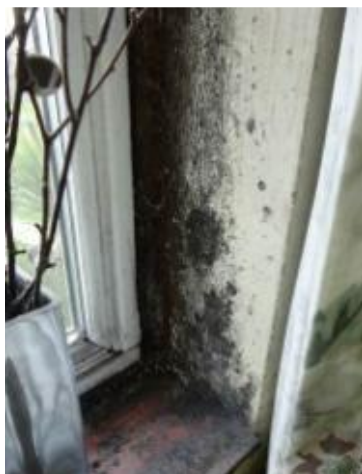
S29 – 39 Mankley Road, Leonard Stanley. Mould in window reveal at sill

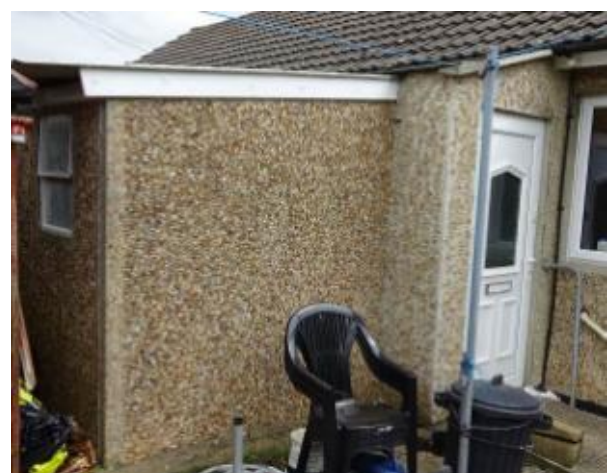
S36 – 38 Glebe Road, Minchinhampton. Outbuilding of Reema panel construction jointed to bungalow

Note: Photographs S28, and S33 to S37 illustrate issues to be dealt with if EWI is installed; ground level too high, conservatories and covered ways, gas meters and pipework.

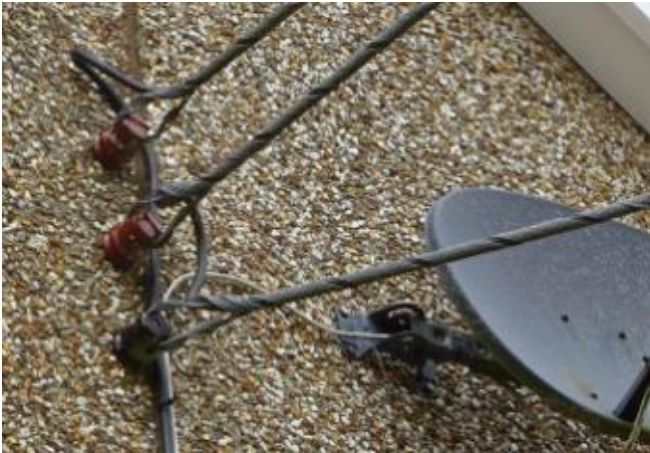
S37 – 38 Glebe Road, Minchinhampton. Overhead electric cables to gable

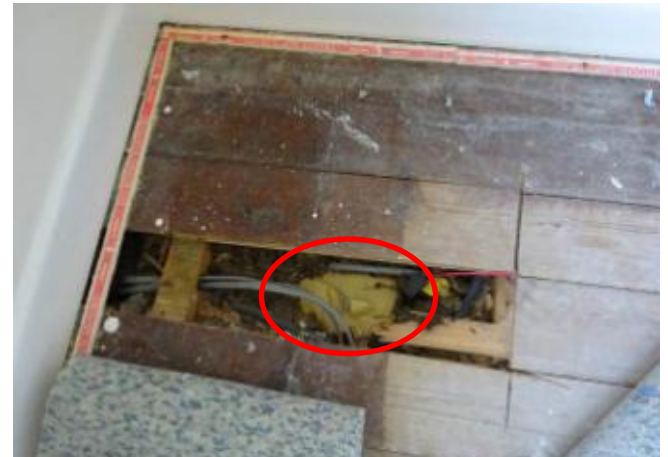
S46 – 3 Upper Park Road, Nailsworth. First floor construction (S47 circled)

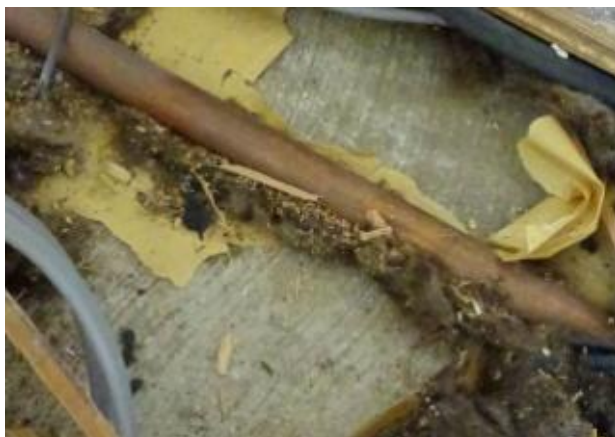
S47 – 3 Upper Park Road, Nailsworth. First floor, suspended cast in-situ concrete slab under floorboards and battens.

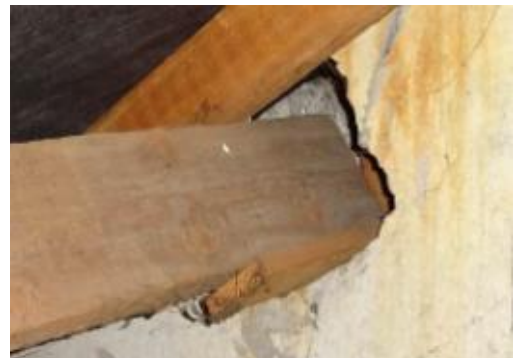
S52 – 3 Upper Park Road, Nailsworth. Roof purlin at party wall. Hole through to other side of wall, risk of fire spread.

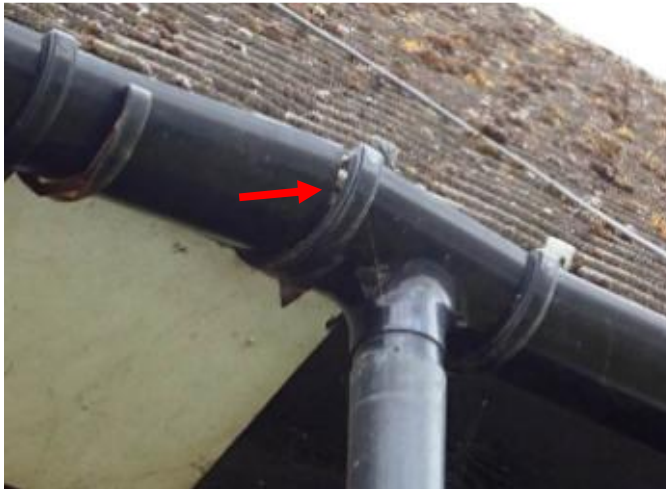
T7 – 32 Barrs Lane, North Nibley. Front gutter disconnected at downpipe bracket (arrowed)

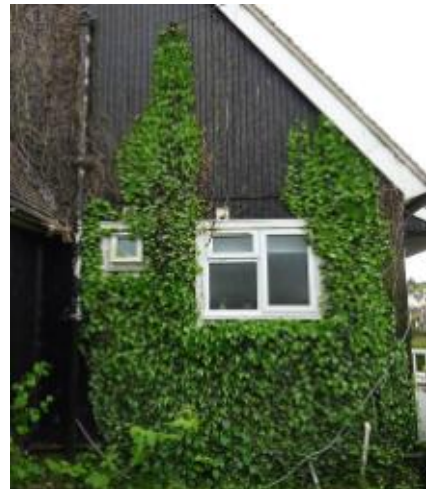
T8 – 32 Barrs Lane, North Nibley. Side, extensive ivy growth

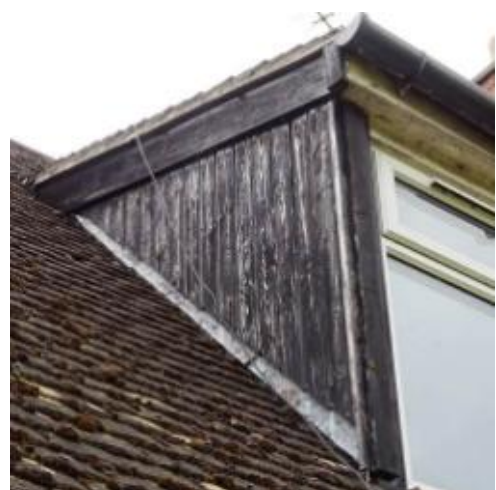
T12 – 32 Barrs Lane, North Nibley. Rear, poor timber to dormer side and architrave

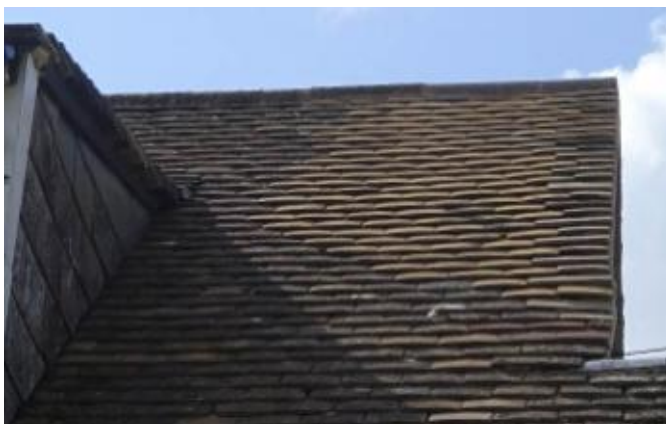
T35 – 3 Mount Pleasant, Wotton-Under-Edge. Gable chimney taken down

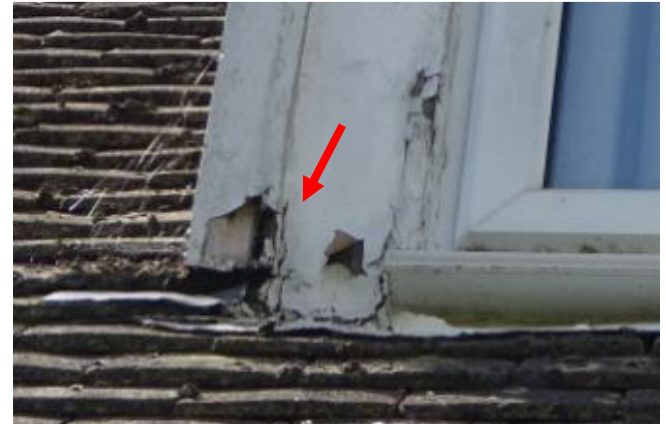
T36 – 3 Mount Pleasant, Wotton-Under-Edge. Rear dormer window poor paint finishes to framing & architrave

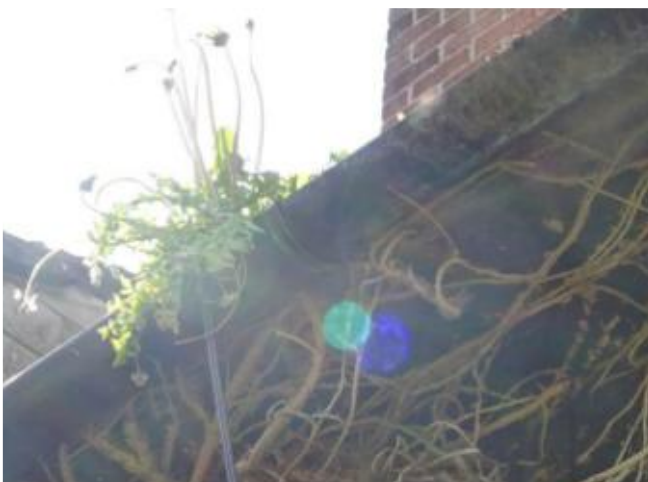
T41 – 7 Mount Pleasant, Wotton-Under-Edge. Rear, gutter vegetation & dead/dormant ivy growth
