## Condition Survey

**Airey  
BL8  
Cornish  
Dorlonco  
Reema Conclad  
Reema Hollow Panel  
Stent  
Swedish  
Unity  
Woolaway**

## **dwellings at various locations**

By Curtins Consulting Ltd  
May 2017

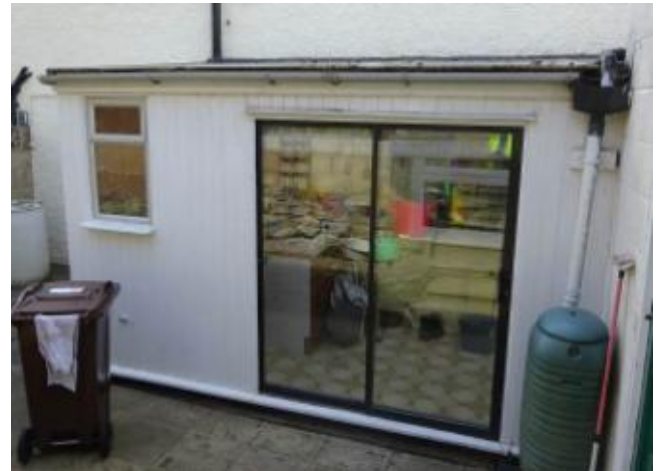
P4 – 14 Hyett Road, Cashes Green, Rear single storey extension

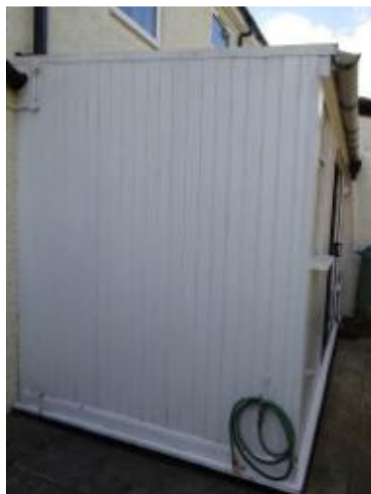
P5 – 14 Hyett Road, Cashes Green, Rear single storey extension

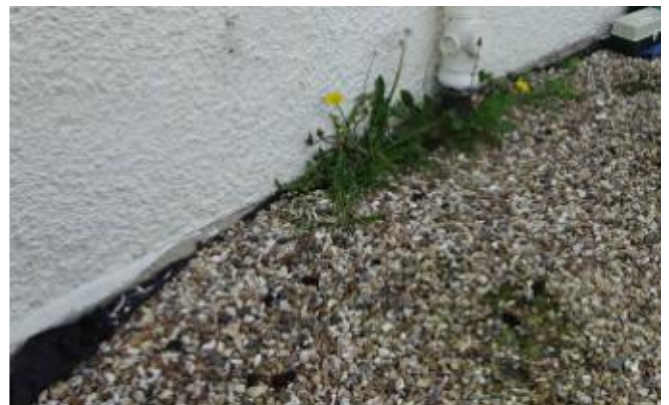
P6 – 14 Mosley Crescent, Cashes Green, ground level at rear too high

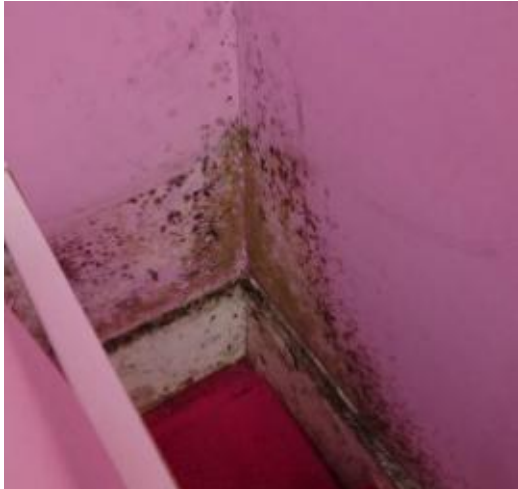
P7 – 14 Mosley Cresnet, Cashes Green, mould in front ground floor room used as bedroom

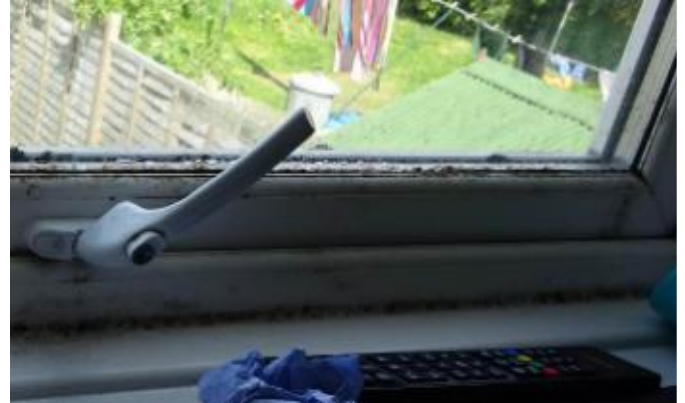
P8 – 14 Mosley Cresnet, Cashes Green, mould on window frame in rear bedroom

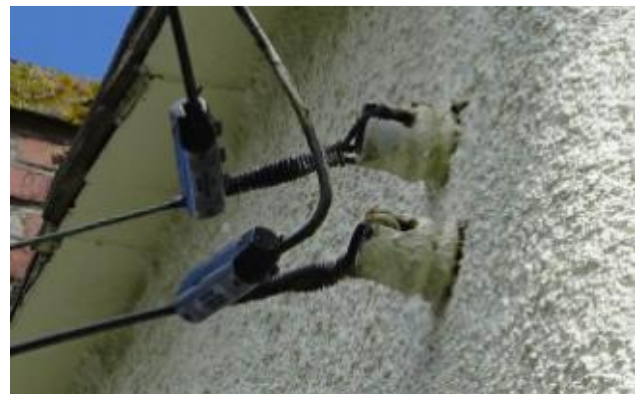
P10 – Overhead power supply fixing at wall, at 10 Kingley Road, Cashes Green

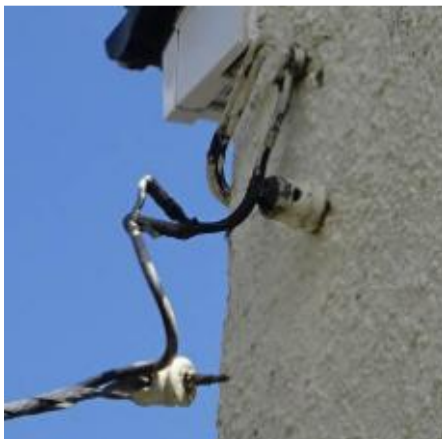
P11 – Overhead power supply fixing at wall, at 14 Hyett Road, Cashes Green

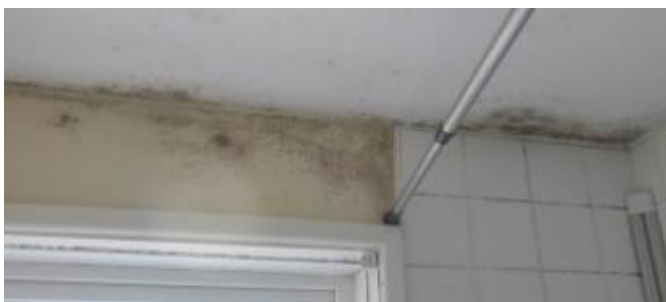
Q11 – 19 Nortonwood, Forest Green, mould in bathroom above window & over bath

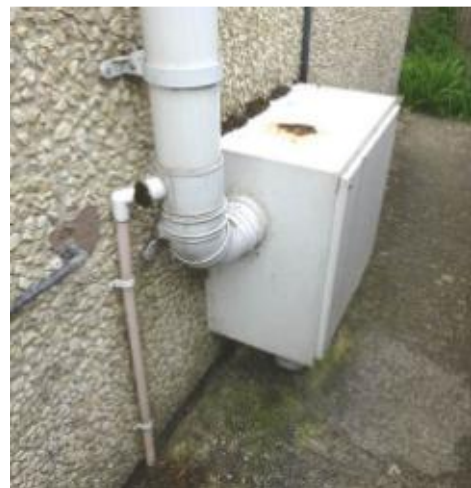
Q16 – Example of Radon Pump (to 1 No in Badgers Way, and 3 No in Woodpecker Way)

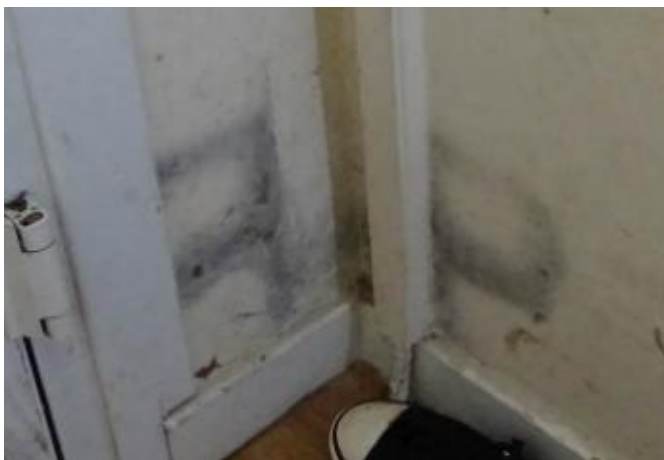
S17 – 12A Lawnside, Forest Green, Hall mould in square shapes on front & alleyway walls

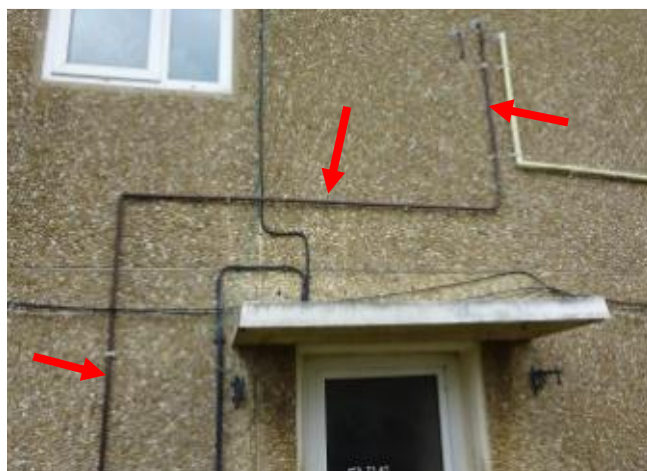
S35 – 51/52 Mankley Road, Leonard Stanley. Gas pipework on external wall

*Note: Photographs S28, and S33 to S37 illustrate issues to be dealt with if EWI is installed; ground level too high, conservatories and covered ways, gas meters and pipework.*

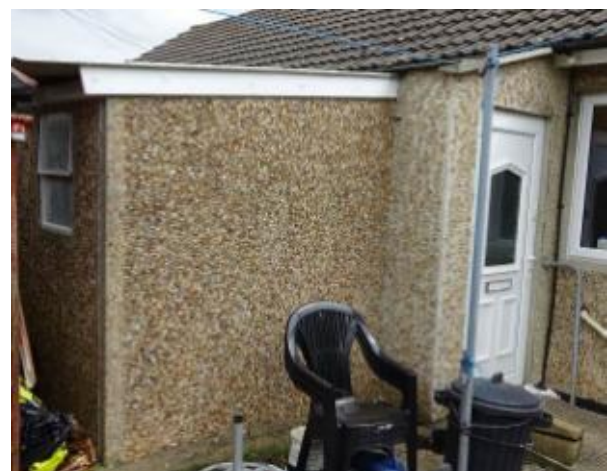
S36 – 38 Glebe Road, Minchinhampton. Outbuilding of Reema panel construction jointed to bungalow

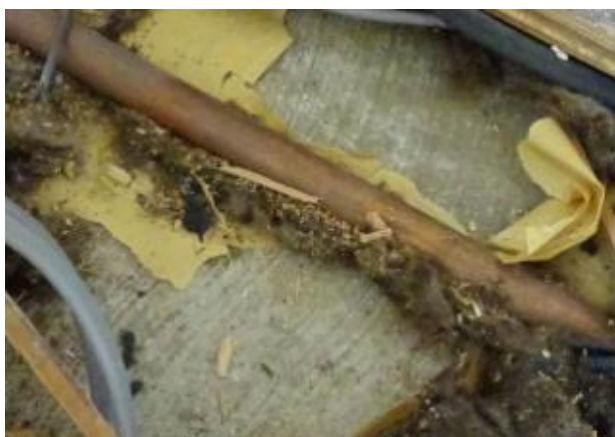
S47 – 3 Upper Park Road, Nailsworth. First floor, suspended cast in-situ concrete slab under floorboards and battens.

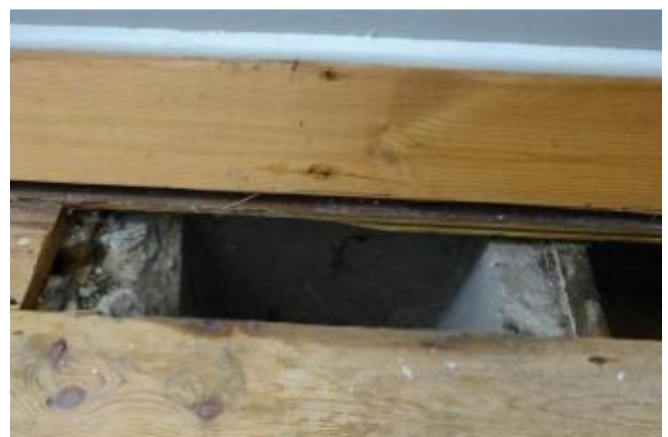
S48 – 6 Upper Park Road, Nailsworth. First floor construction, PRC ladder beams (see S49 for general view, taken in another house not in SDC stock)

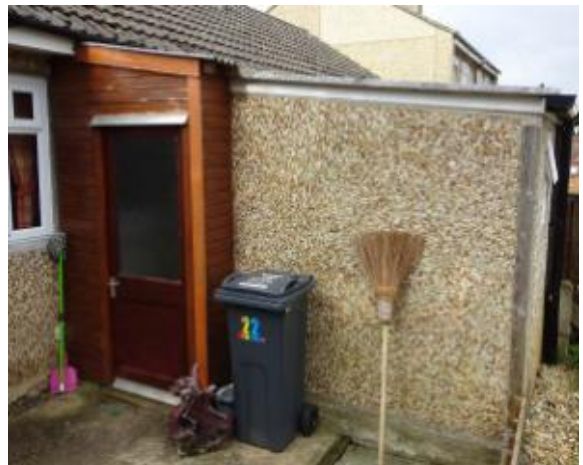
S58 – 22 Willow Road, Stonehouse. Outbuilding joined to the bungalow (note: Outbuilding is of Reema panel construction)

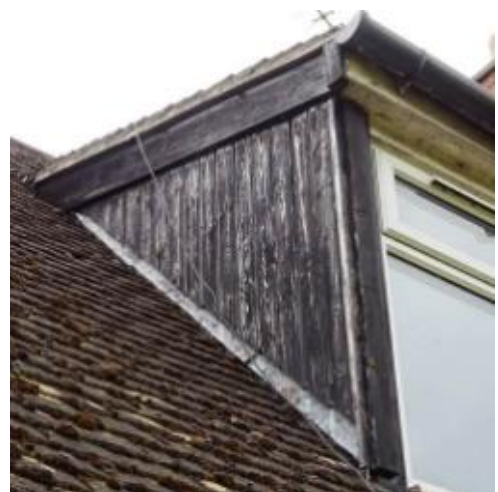
T12 – 32 Barrs Lane, North Nibley. Rear, poor timber to dormer side and architrave

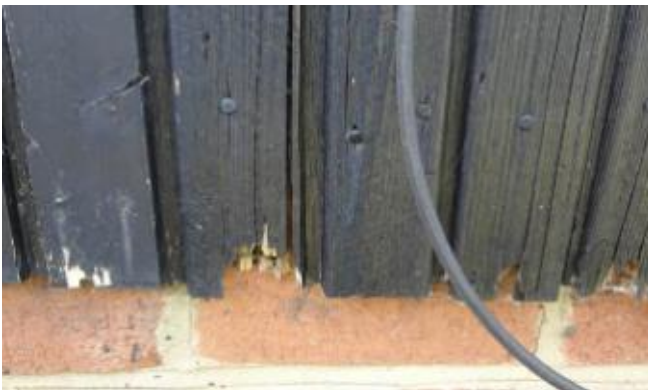
T39 – 7 Mount Pleasant, Wotton-Under-Edge. Rear, rotten outer boards at dpc level
