HOUSING COMMITTEE

Non-Traditional Homes Summary Property Review

Prepared for:
Stroud District Council
Council Offices
Ebley Mill
Ebley Wharf
STROUD
Gloucestershire
GL5 4UB

Curtin's Consulting Limited were appointed by Stroud District Council (referred to in their report as SDC or the Council) to undertake a survey and prepare a report on the condition of the remaining non-traditional properties which remain with the Councils housing portfolio.

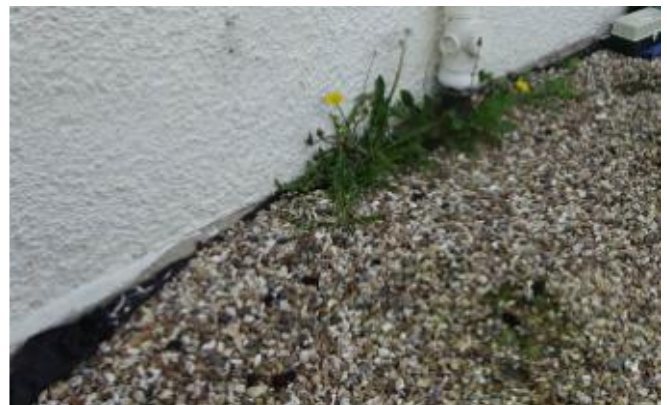
P6 – 14 Mosley Crescent, Cashes Green, ground level at rear too high

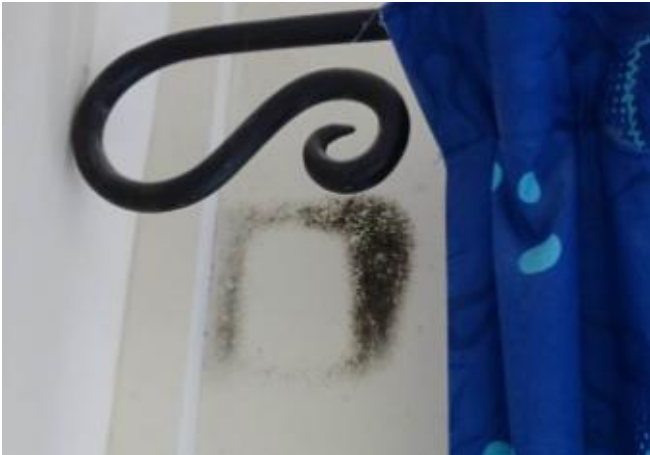
S19 – 12A Lawnside, Forest Green, Bedroom
mould to left of window high level

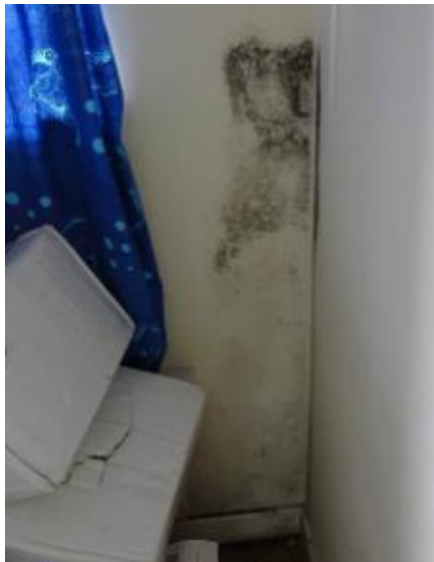
S21 – 12A Lawnside, Forest Green, Bedroom
mould to right of window mid height

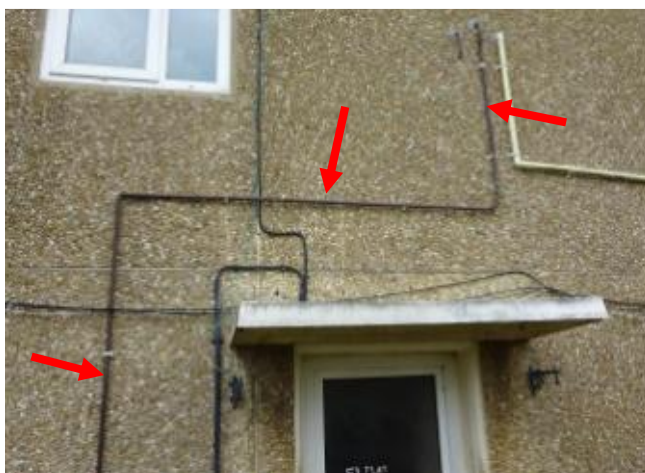
S35 – 51/52 Mankley Road, Leonard Stanley. Gas pipework on external wall

Note: Photographs S28, and S33 to S37 illustrate issues to be dealt with if EWI is installed; ground level too high, conservatories and covered ways, gas meters and pipework.

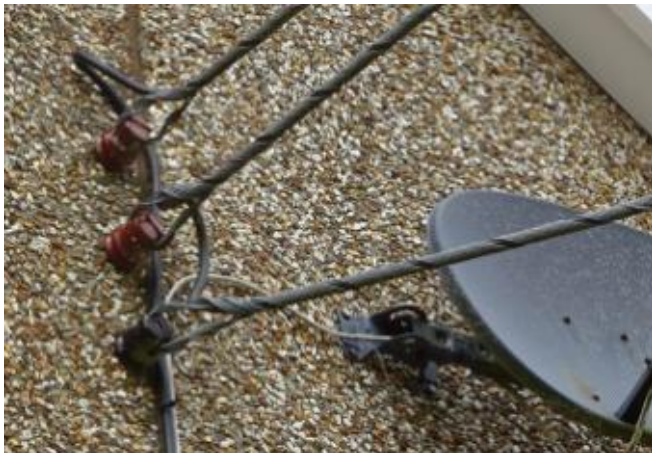
S37 – 38 Glebe Road, Minchinhampton. Overhead electric cables to gable

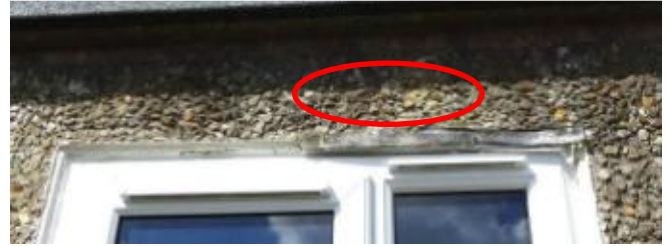
S62 – 31 Victory Road, Whiteshill. Side extension cracking above window (S63 circled)

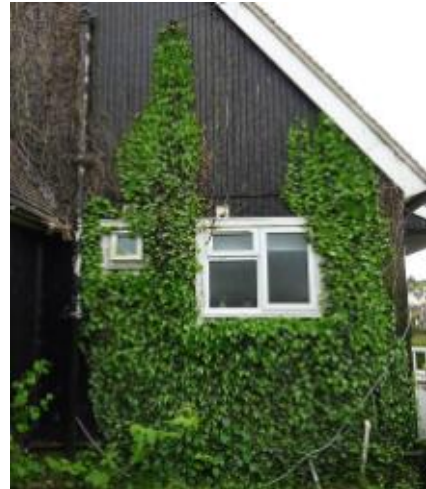
T8 – 32 Barrs Lane, North Nibley. Side, extensive ivy growth

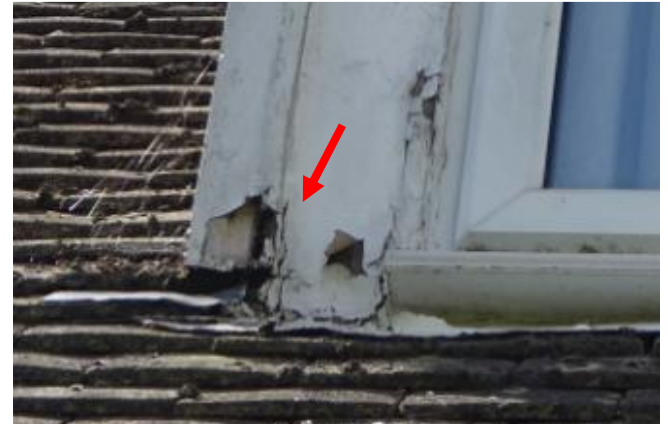
T36 – 3 Mount Pleasant, Wotton-Under-Edge. Rear dormer window poor paint finishes to framing & architrave

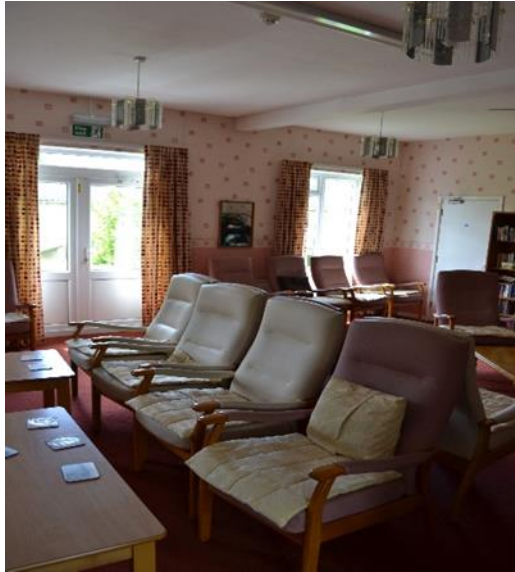
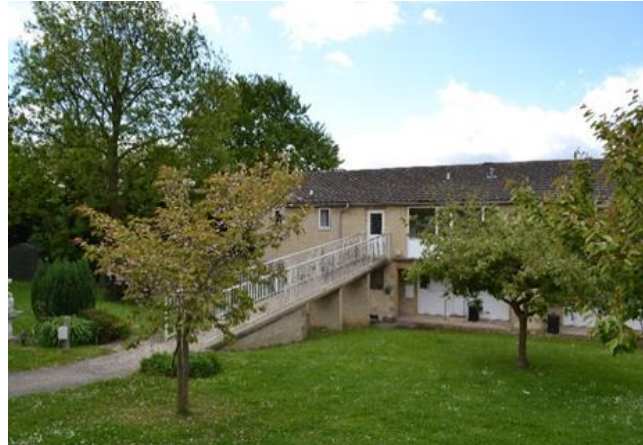
The overall quality of accommodation at Burdett House is poor – although homes have benefitted from improvements the bedsits are small and relatively unpopular. Although there is little 'competing' provision the area is well-served by alternative Council accommodation. These factors contribute to very long void times and high level of refusals.

The number and cost of repairs raised each year appear satisfactory. The communal lounge, although well used has an unwelcoming 'institutional' feel.

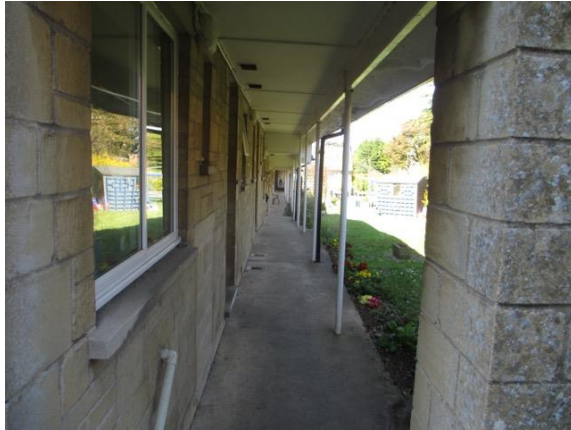
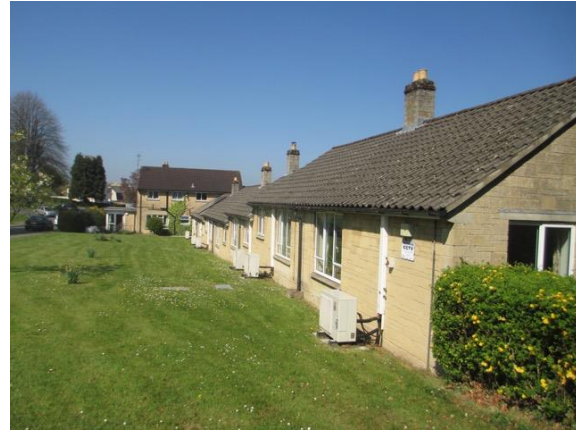
There is a high number of long-standing residents with a third over 80 and with 15 per cent over 90. Despite this, the turnover of tenancies and the number of refusals are high. The most common reasons given for refusals are that the property or area is unsuitable or the home is too small.

The overall design and construction falls well below modern standards. Homes are often small, badly arranged with poor natural lighting and insulation. The number of repairs appears satisfactory but repair costs are relatively high which may reflect the age and construction of the scheme.

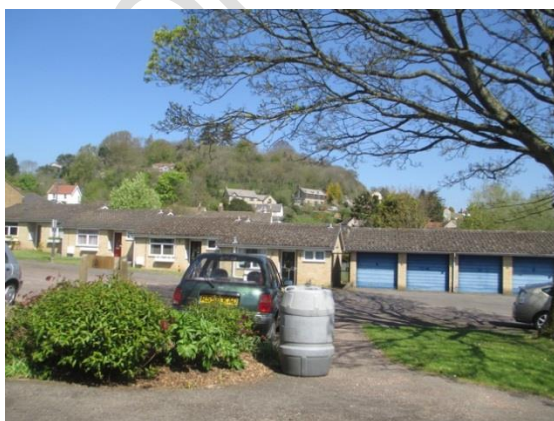
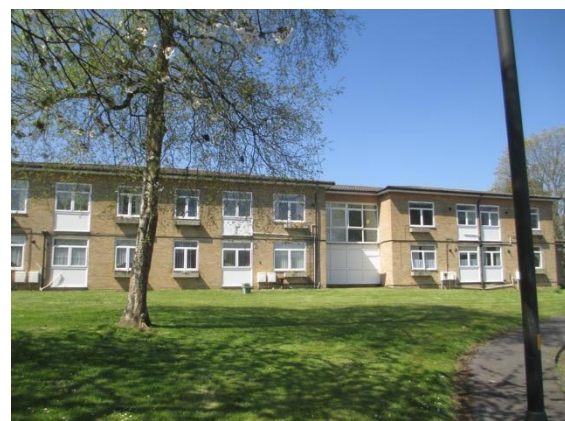
Dryleaze Court's biggest weakness is the poor quality of accommodation. There is a high concentration of bedsits which are small and difficult to let. The scheme itself is relatively unattractive with some evidence of under investment in maintenance and decorative repair.

The number of repairs carried out and spend on repairs and voids are in line with the expected benchmark but arguably lower than the scheme needs. Some homes do not currently meet the Decent Homes Standard and some first floor flats are not served by a lift. Consequently, Dryleaze Court has 18 long-term voids with an average void time of over 850 days.

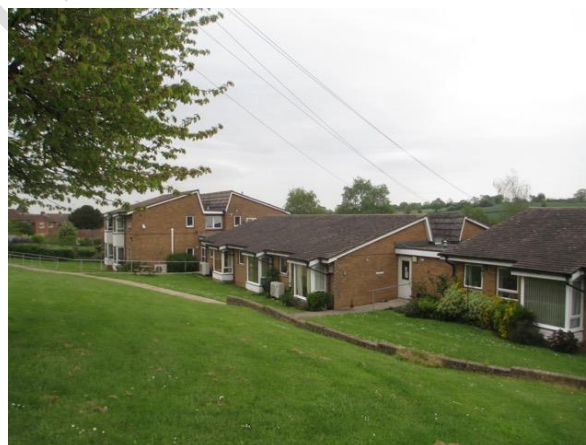
These issues contribute to a high number of refusals, long-term voids and some very long void times. Turnover in the scheme is also very high which is likely to be a reflection of the large number of small bedsits.

The number of repairs carried out is in line with the expected benchmark and the data suggests repairs spend is very low. The reliability of this data should be reviewed as we do not believe that all homes currently meet the minimum Decent Homes Standard.

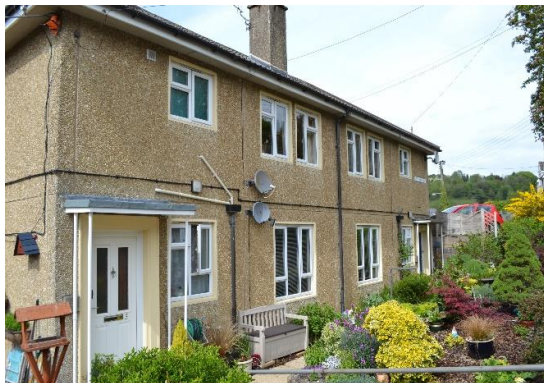
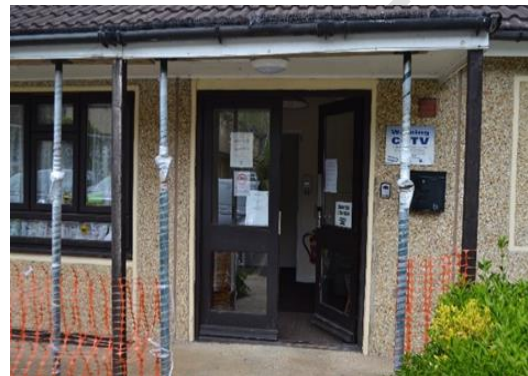
The properties are 'as built' with patch repairs and some remedial work carried out to sustain their ongoing use.

Inevitably, these homes experience a very high level of repairs and spend. This presents a number of risks to the Council and will continue to do so without significant investment to protect the structure and fabric of homes.

The properties are spacious and in a popular location. The large communal lounge is regularly used. However, turnover of tenancies is high. Car parking is insufficient for resident's needs, there is no lift access to first floor flats and the scooter store does not meet modern standards.

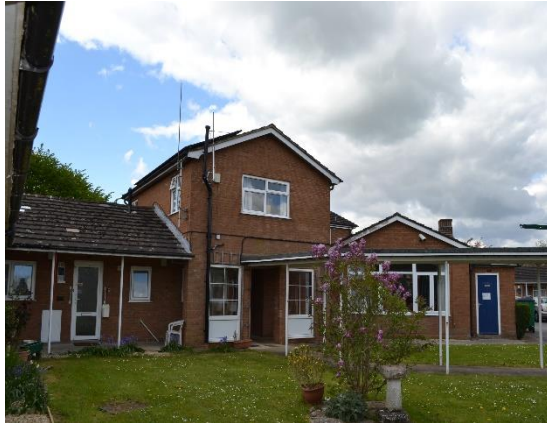
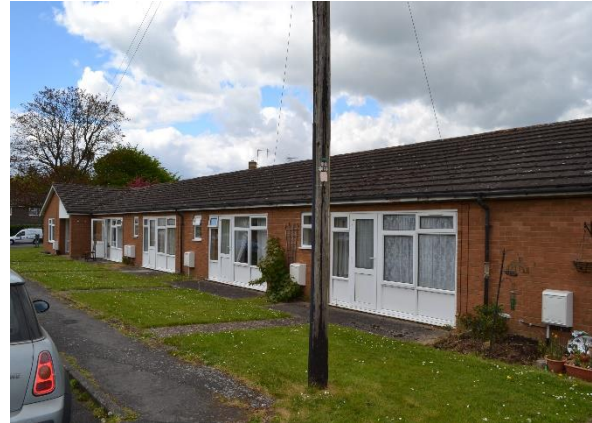
Homes often have narrow doorways with raised entrance thresholds. Some of the homes suffer from disrepair and need investment in external elements such as fascias, soffits and windows.

Tenancy turnover is high and the smaller bungalows can be hard to let.
