Non-Traditional Homes Summary Property Review

Prepared for:
Stroud District Council
Council Offices
Ebley Mill
Ebley Wharf
STROUD
Gloucestershire
GL5 4UB

February 2018

Condition Survey

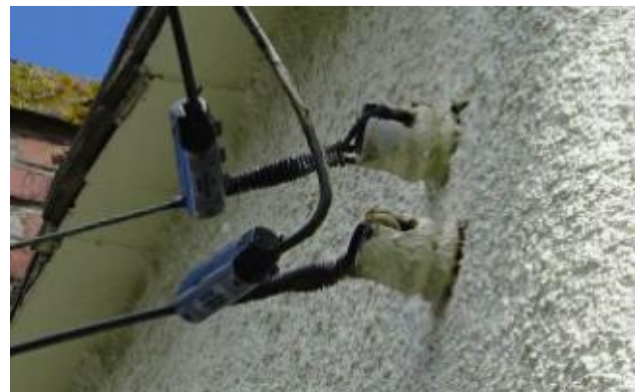
P10 – Overhead power supply fixing at wall, at 10 Kingley Road, Cashes Green

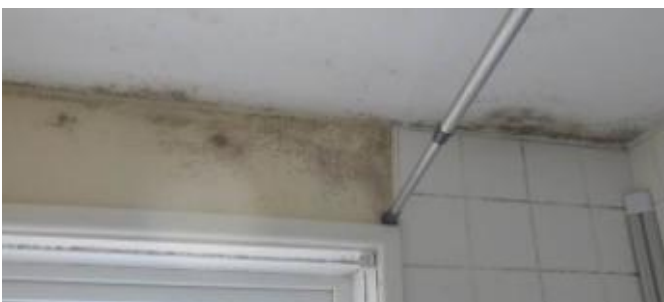
Q11 – 19 Nortonwood, Forest Green, mould in bathroom above window & over bath

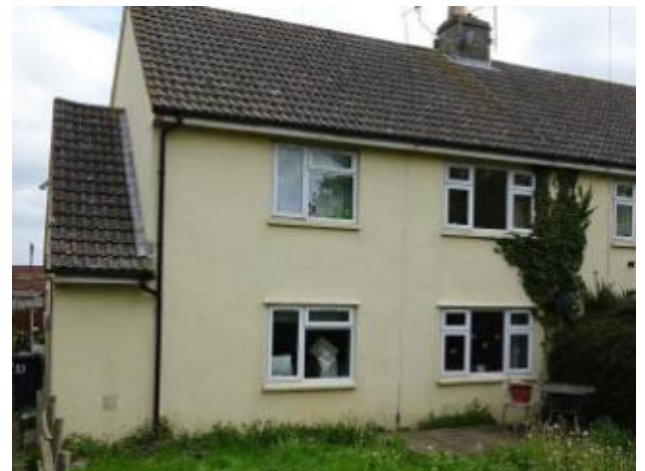
S16 – Brimley, Leonard Stanley, three houses (Nos 53, 54 & 55) not Reema construction

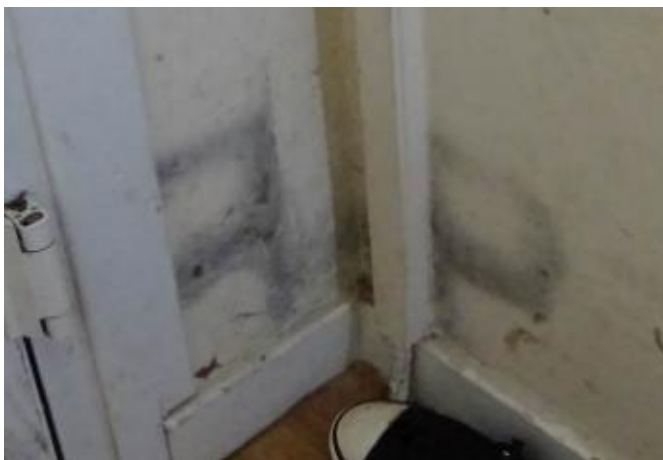
S17 – 12A Lawnside, Forest Green, Hall mould in square shapes on front & alleyway walls

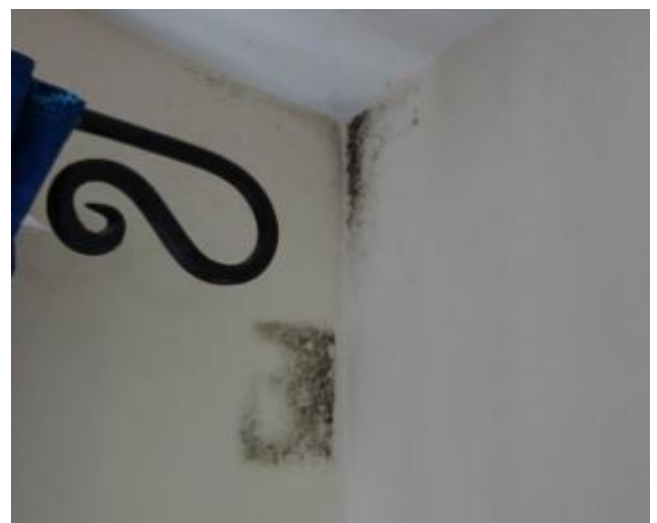
S18 – 12A Lawnside, Forest Green, Bedroom mould to right of window high level

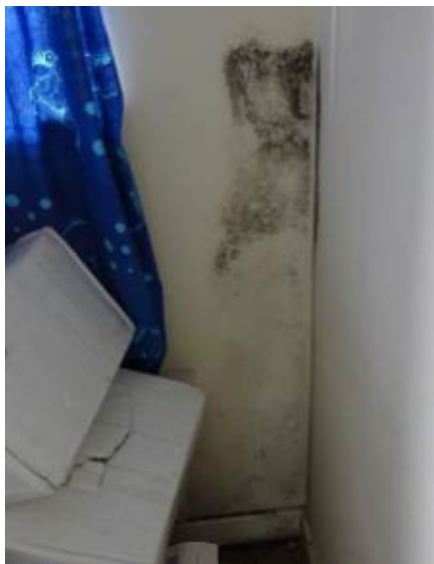
S21 – 12A Lawnside, Forest Green, Bedroom
mould to right of window mid height

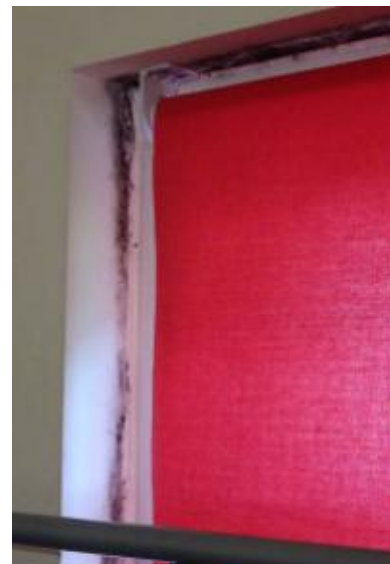
S22 – 12A Lawnside, Forest Green, Bedroom 2
mould on window reveal & head

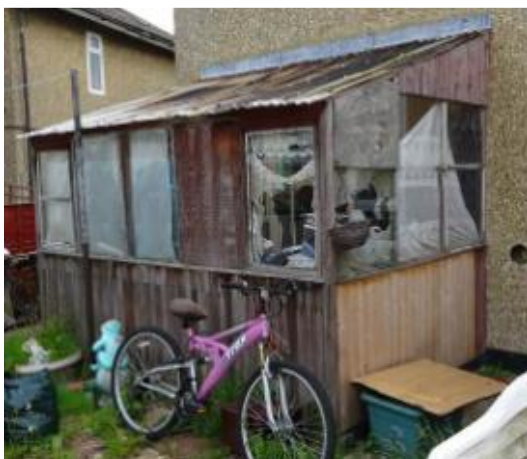
S33 – 39 Mankley Road, Leonard Stanley. Rear conservatory.

Note: Photographs S28, and S33 to S37 illustrate issues to be dealt with if EWI is installed; ground level too high, conservatories and covered ways, gas meters and pipework.

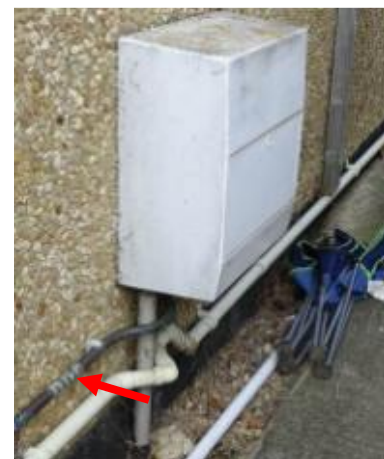
S34 – 39 Mankley Road, Leonard Stanley. Gas meter box & pipework

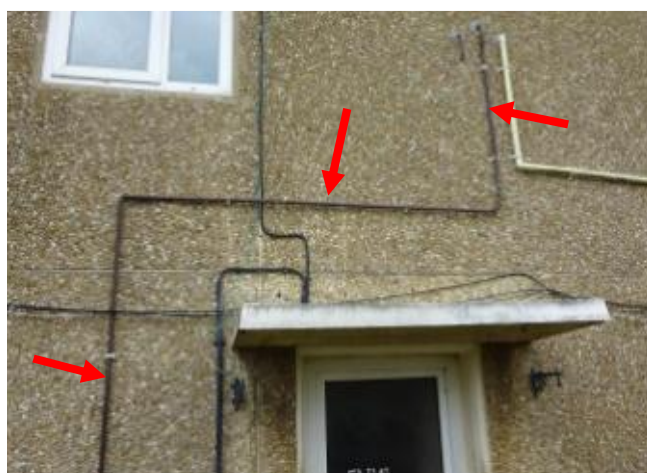
S35 – 51/52 Mankley Road, Leonard Stanley. Gas pipework on external wall

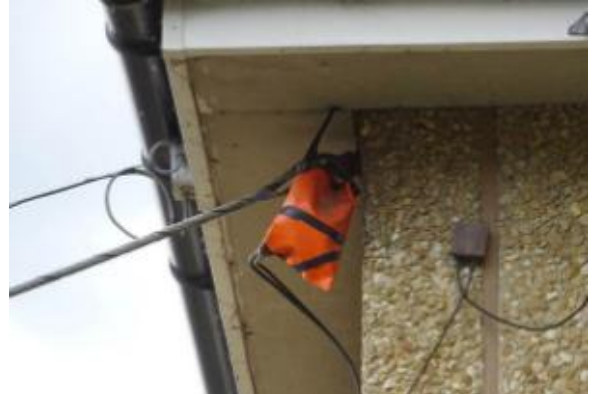
S56 – 3 Upper Park Road, Nailsworth. Overhead electric cables

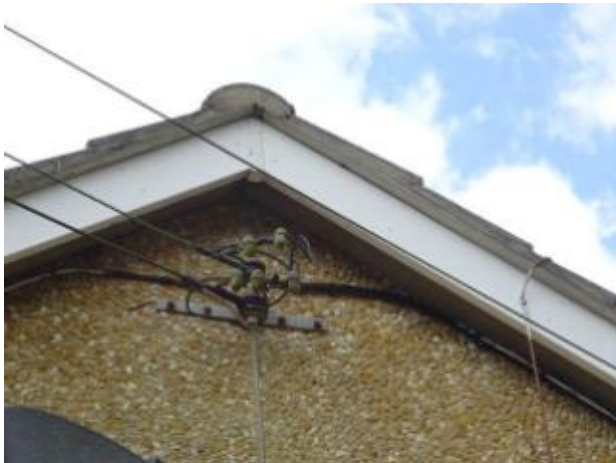
S57 – 6 Upper Park Road, Nailsworth. Overhead electric cables

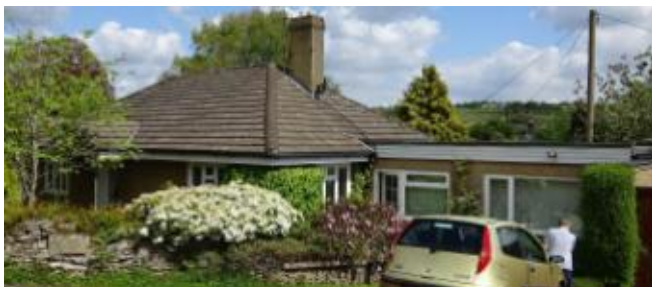
S71 – High Field, Woodchester, general view

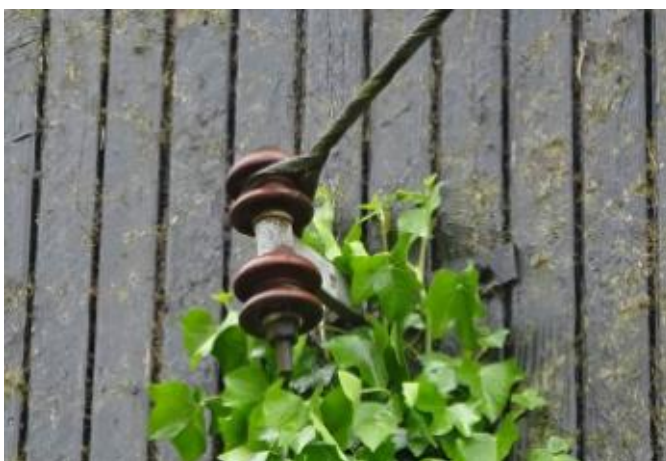
T11 – 32 Barrs Lane, North Nibley. Incoming mains electrics on side elevation

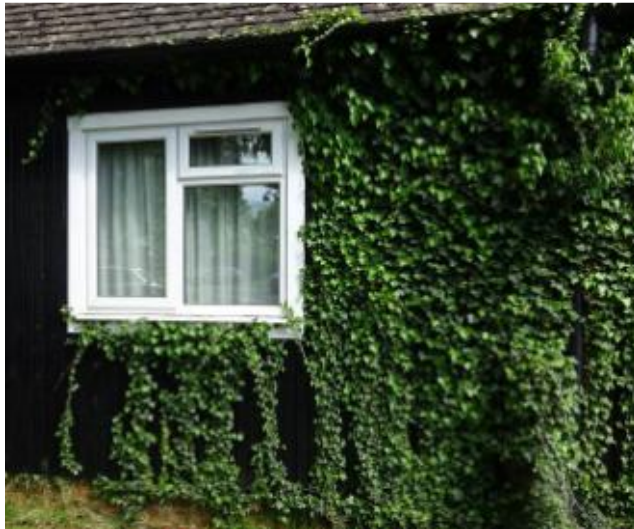
T31 – 3 Mount Pleasant, Wotton-Under-Edge. Front, extensive ivy growth

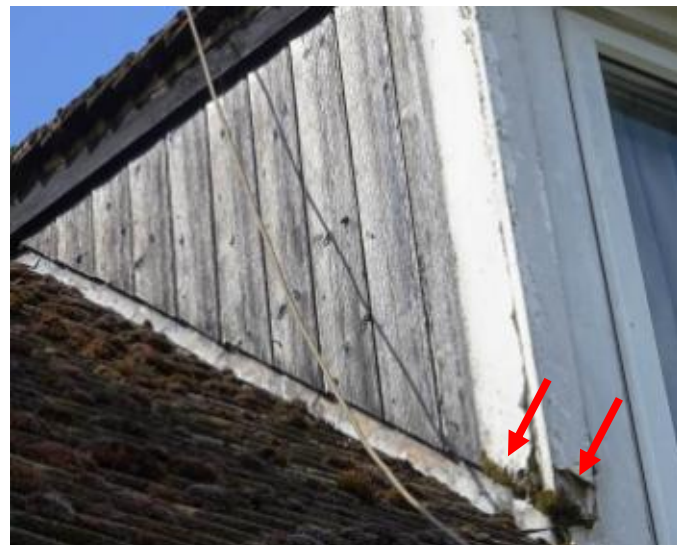
T40 – 7 Mount Pleasant, Wotton-Under-Edge. Rear, poor timber to dormer side, and architrave rotten near roof tiles (arrowed)
