## Condition Survey

**Airey  
BL8  
Cornish  
Dorlonco  
Reema Conclad  
Reema Hollow Panel  
Stent  
Swedish  
Unity  
Woolaway**

## **dwellings at various locations**

By Curtins Consulting Ltd  
May 2017

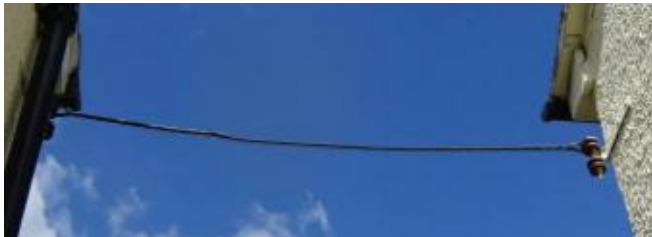
P9 – Typical overhead power supply cables between buildings (this one at 14 Mosley Cresnet, Cashes Green)

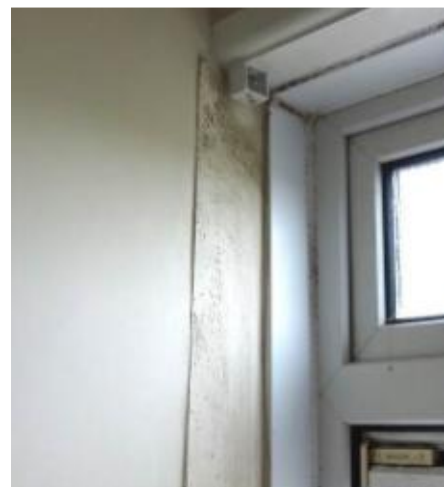
Q12 – 19 Nortonwood, Forest Green, mould in bathroom in window reveal

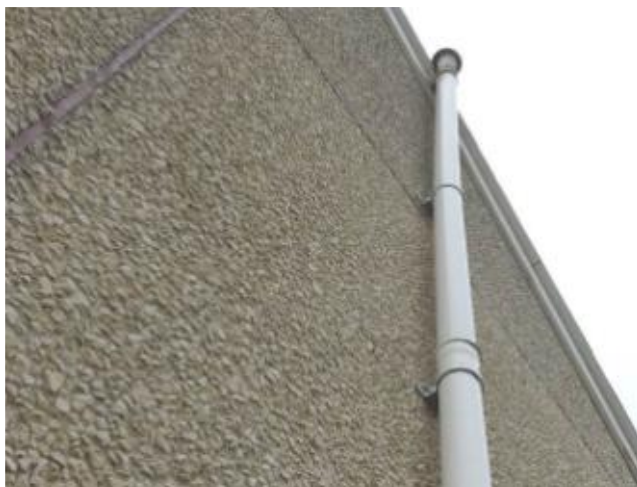
Q17 – Example of Radon ducting from pump

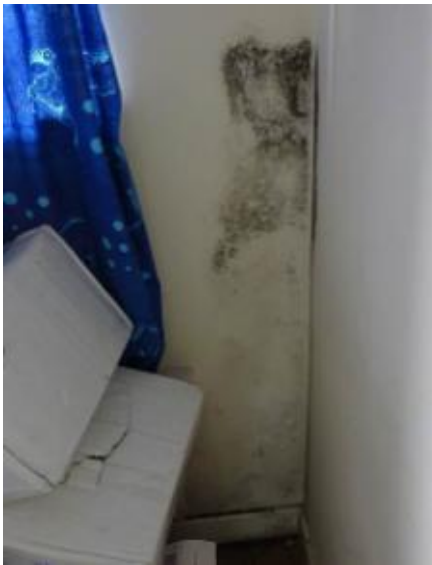
S21 – 12A Lawnside, Forest Green, Bedroom  
mould to right of window mid height

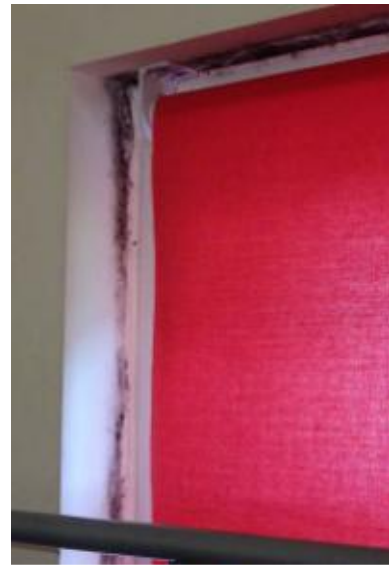
S22 – 12A Lawnside, Forest Green, Bedroom 2  
mould on window reveal & head

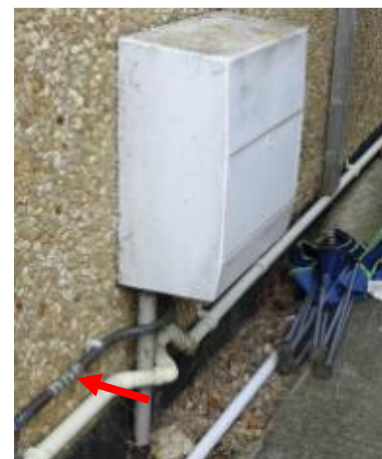
S34 – 39 Mankley Road, Leonard Stanley. Gas meter box & pipework

*Note: Photographs S28, and S33 to S37 illustrate issues to be dealt with if EWI is installed; ground level too high, conservatories and covered ways, gas meters and pipework.*

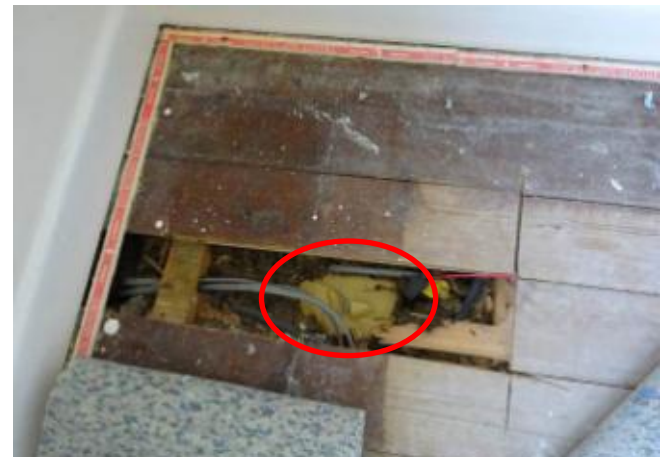
S46 – 3 Upper Park Road, Nailsworth. First floor construction (S47 circled)

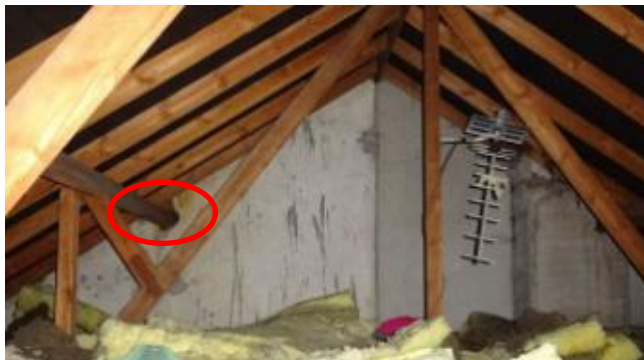
S51 – 3 Upper Park Road, Nailsworth. General View in Loft towards the party wall (S52 circled)

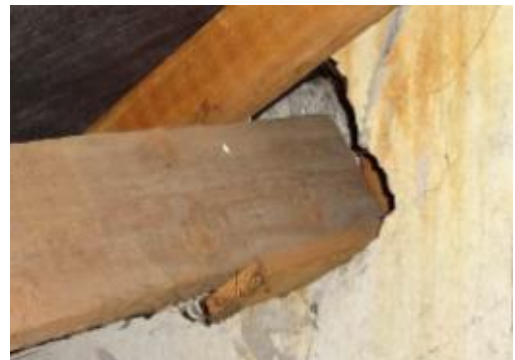
S52 – 3 Upper Park Road, Nailsworth. Roof purlin at party wall. Hole through to other side of wall, risk of fire spread.

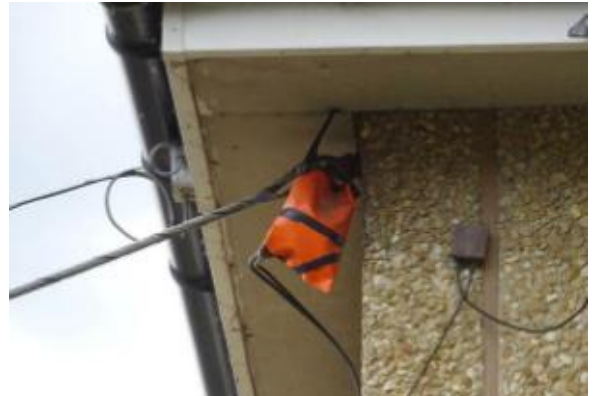
S56 – 3 Upper Park Road, Nailsworth. Overhead electric cables

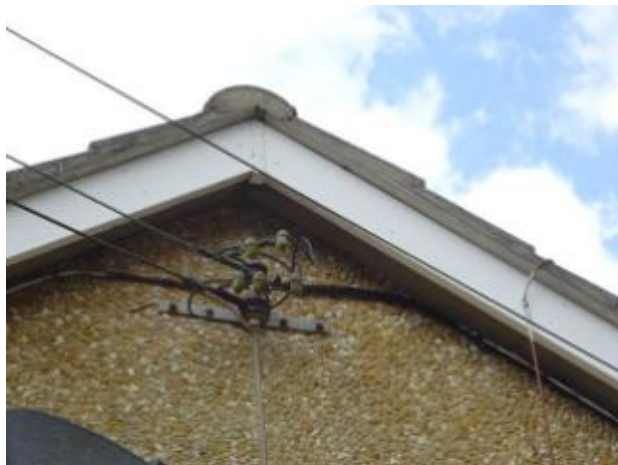
S57 – 6 Upper Park Road, Nailsworth. Overhead electric cables

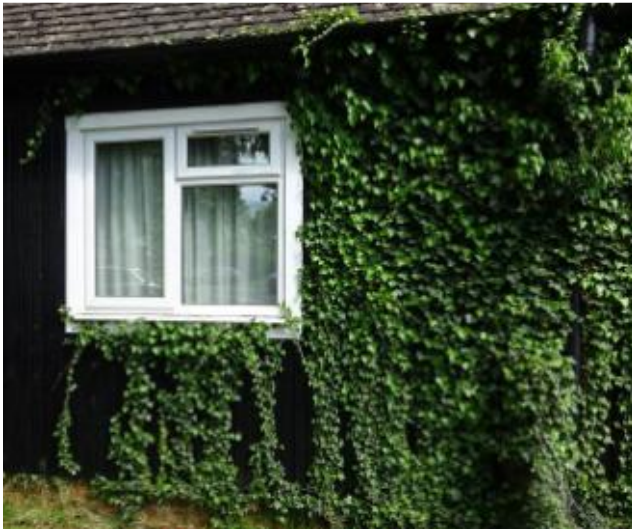
T31 – 3 Mount Pleasant, Wotton-Under-Edge. Front, extensive ivy growth

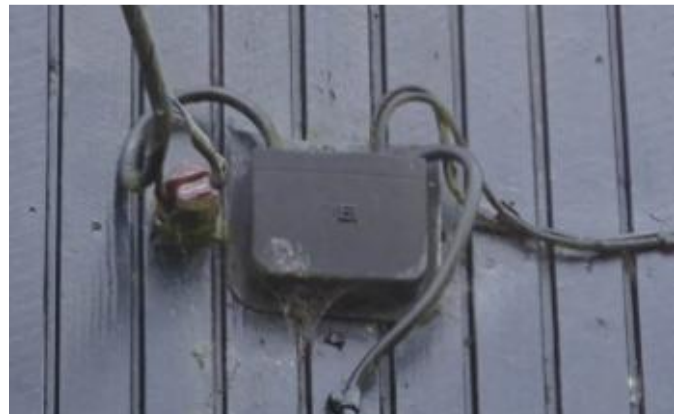
T34 – 3 Mount Pleasant, Wotton-Under-Edge. Incoming mains electrics on side elevation

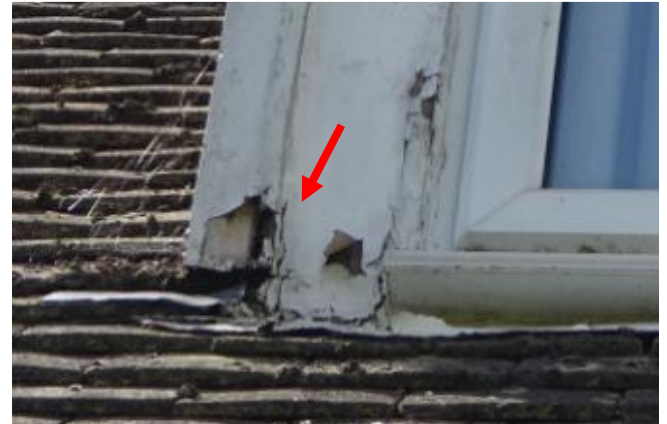
T36 – 3 Mount Pleasant, Wotton-Under-Edge. Rear dormer window poor paint finishes to framing & architrave
